Fisheries Habitat Restoration Project

Final Report 2020-2021

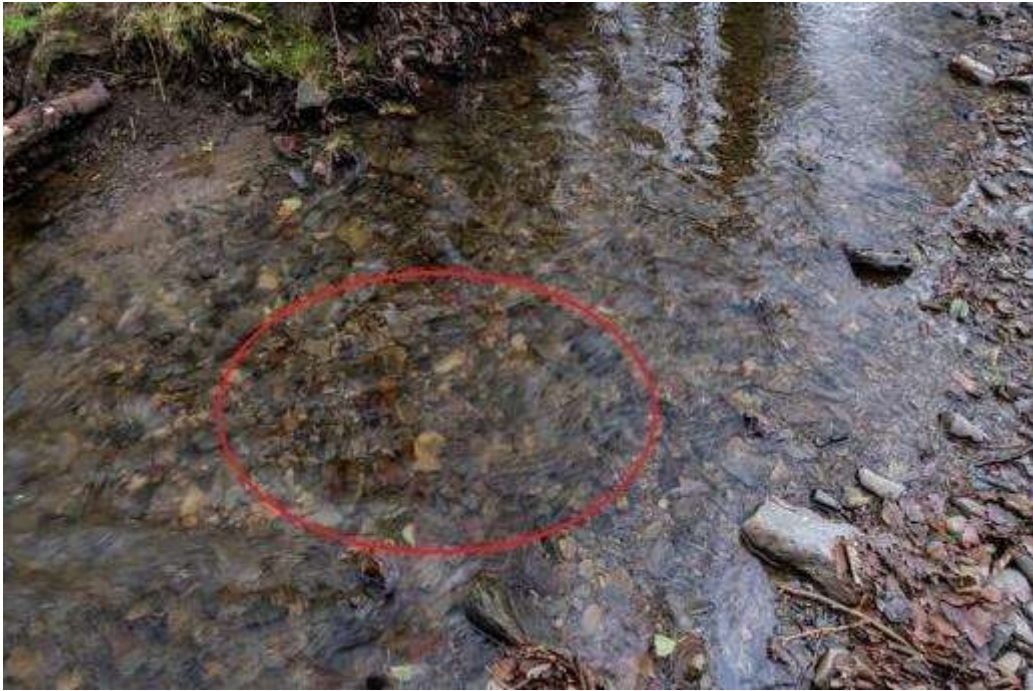
Above: Redd on the Afon Concwest (NWRT) above easement works. No fish recorded above this point in previous surveys. Dec 20.

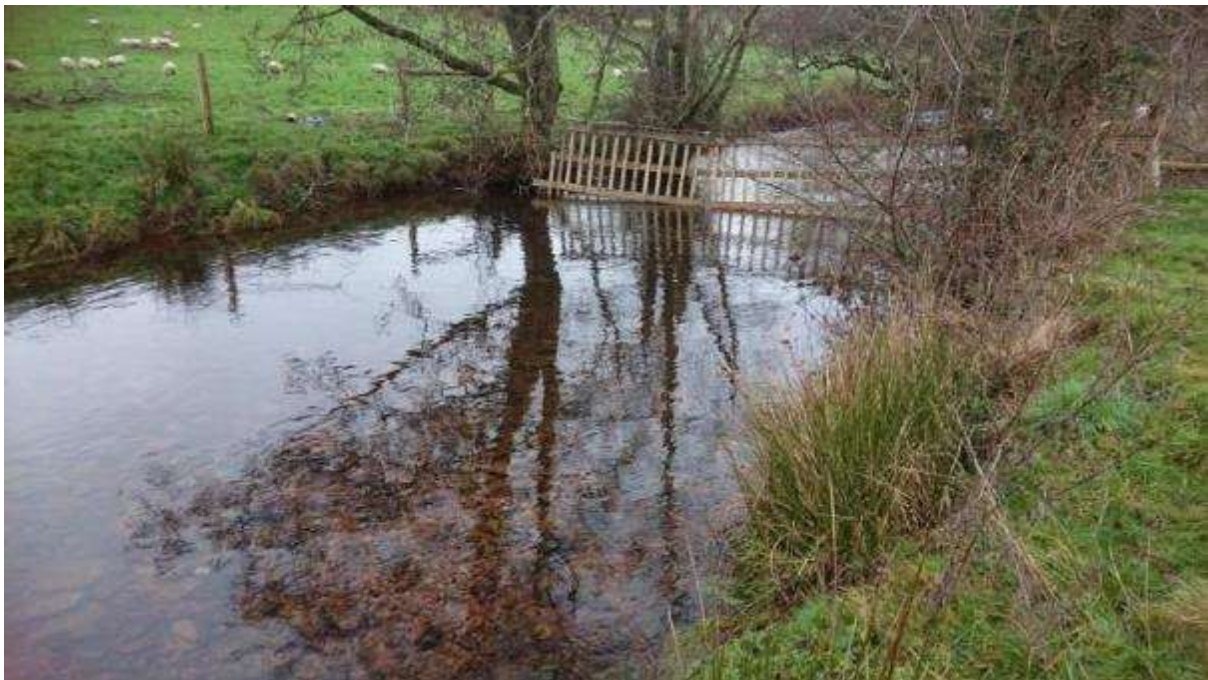
Below: Redd seen on Afon Bran (WUF) directly within habitat restoration site. Dec 20.

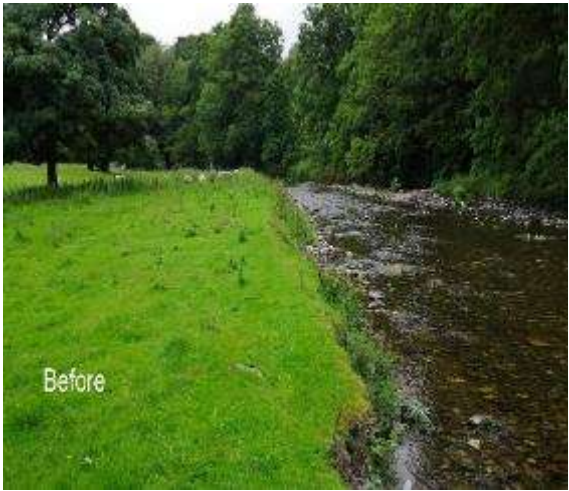
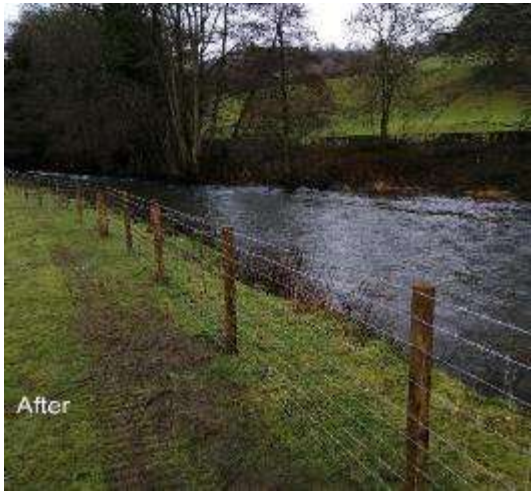
Habitat Restoration	
Catchment	Dyfrddwy (Ceiriog)
NGR	SJ 25262 38238; SJ 25801 37857; SJ 28461 37080
Story	Severe bank erosion is occurring on sections of bank of the Ceiriog river due to a combination of poaching and flooding. We installed roughly 900m of stock fencing along the river at one sheep farm and two mixed livestock farms. We also planted ~ 70 native riparian tree species on the outside of the fence to create habitat variety and provide some stability on the bank. The total cost of the fencing was £7,120.80 and included rails and stock gates and trees were sourced free from the Woodland Trust. The fencing will provide some protection for the banks and hopefully allow vegetation to root and grow, undisturbed by livestock.
Photos Before

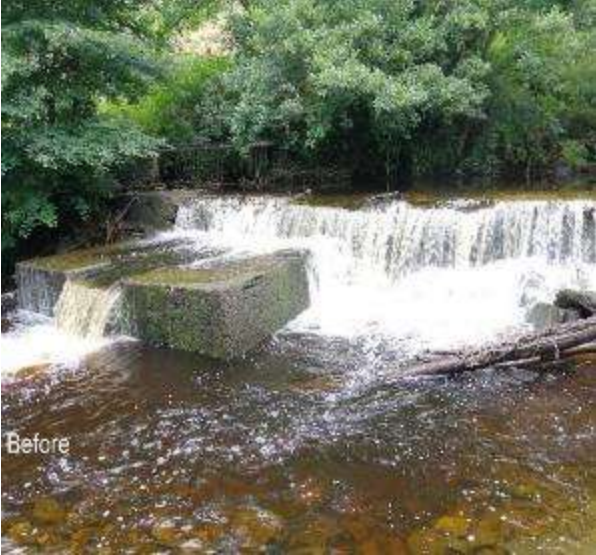
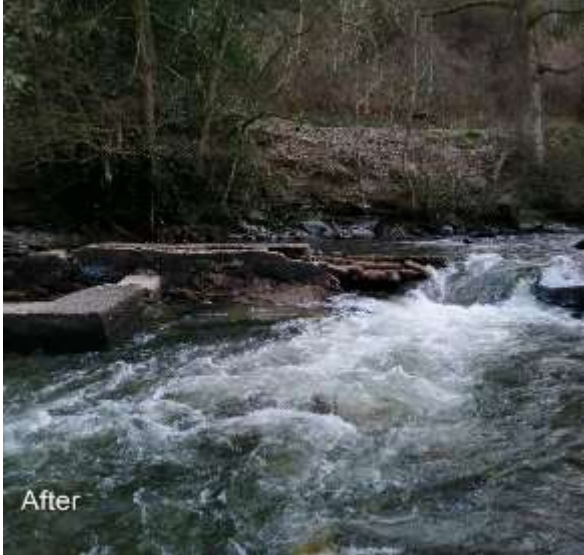
Fish Passage	
Catchment	Dyfrddwy (Upper Mills Trout Farm/Box weir)
NGR	SJ 20203 37337
Story	<p>The old “box weir” at Upper Mills Trout Farm (no longer a fish farm) in Glyn Ceiriog has long been suspected as a partial barrier to fish migration and has had a major impact on the hydrology and morphology of the Ceiriog river both up and downstream of its location. WDT commissioned a specialist to conduct a feasibility study for fish passage at the barrier and develop an outline design for a non-technical</p>

option (easement). The consultant completed the outline design in time but in mid-January, Wales experience significant and prolonged rainfall and record high flood waters. During these floods, the weir was naturally breach in the centre of the structure, resulting in a large “notch” that is now ideal for fish passage. Discussions are ongoing with the landowner to ensure the status is maintained while also ensuring support for the landowner’s water abstraction scheme to keep his pond full.
Photos Before		Photos After

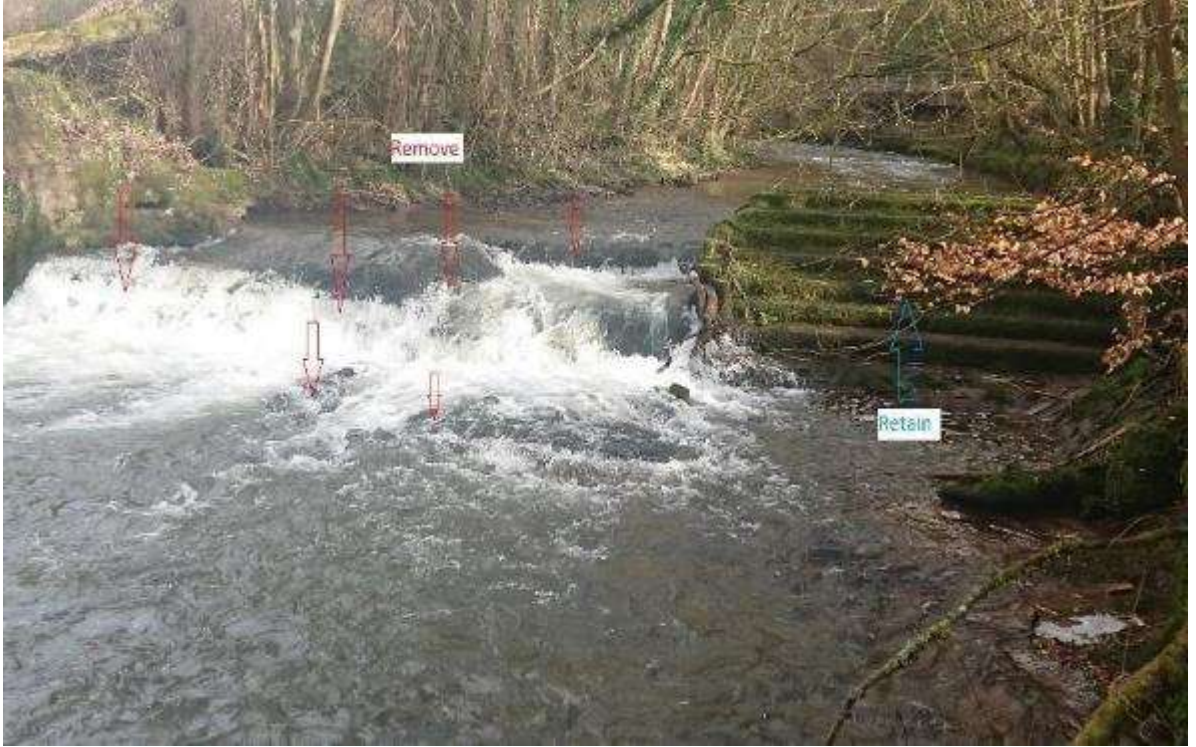
Fish Passage	
Project	Brecon Honddu weir
Action	Visited by LMA, Need Geomorph survey for FRAP. Geomorph survey purchased. Owners consents in place.
NGR	SO 04090 29720
Cost	Geomorph £8730

Story	Remove all redundant concrete from channel except structure on Left bank

Lessons learned	Geomorph needed regardless as Main river

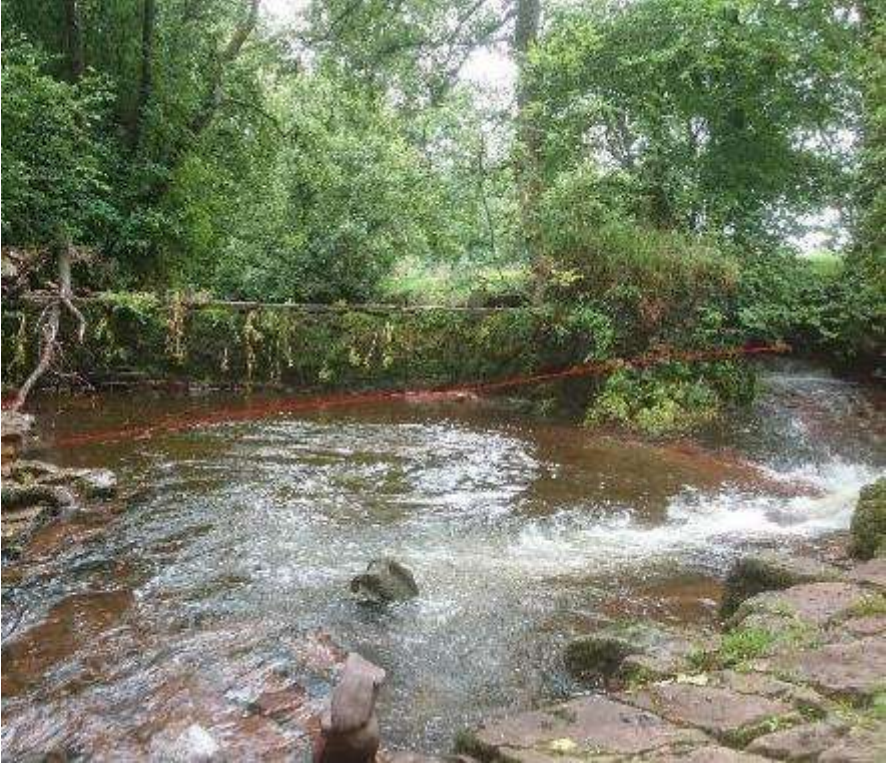
Fish Passage	
Project	Libanus weir, Tarell
NGR	SN 99550 25760
Cost	Geomorph £8042.5
Action	Visited by LMA, Need Geomorph survey for FRAP. Geomorph survey ordered. Owners consents in place.

Story	Owner has had all the details and meeting with LMA. Left to digest and discuss with family as to what they would like to do. Full removal or lower crest. Will discuss further after survey report. But likelihood of leaving for now.

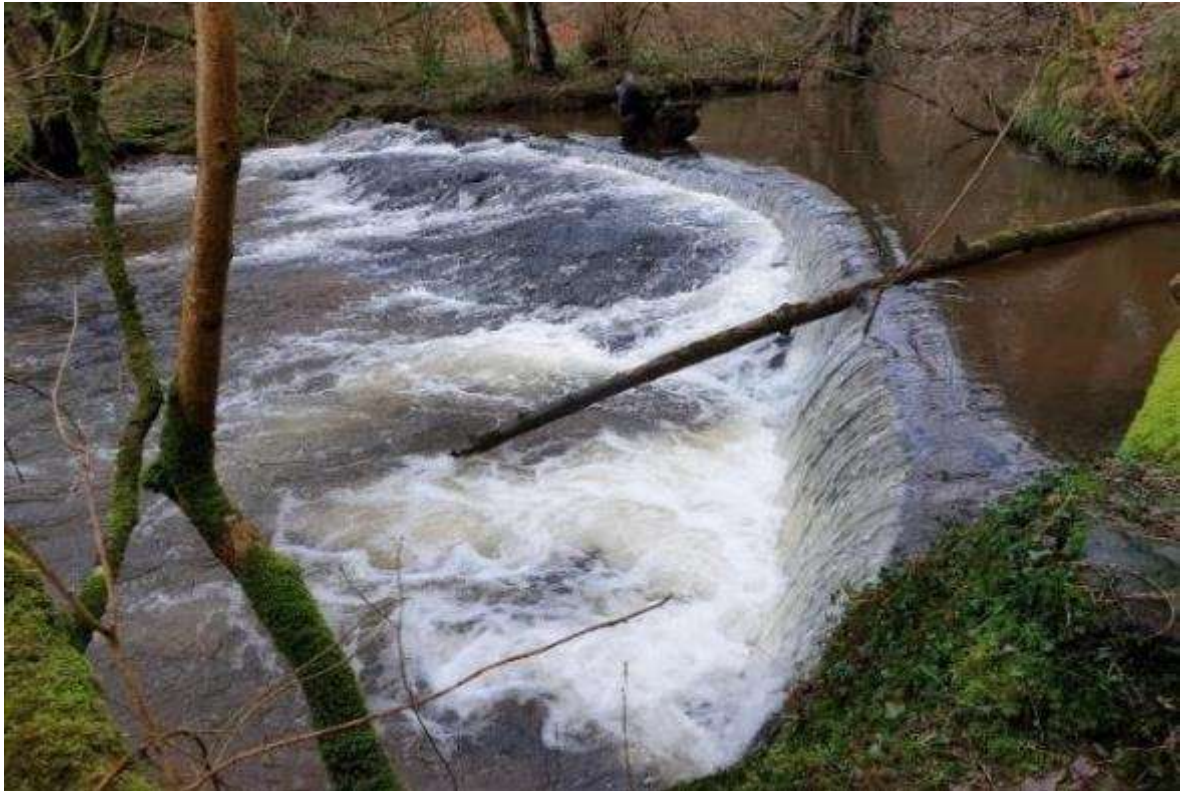
Fish Passage	
Project	Brecon Honddu Llethergynuen weir
NGR	SO 03730 32870
Cost	Geomorph £7105
Action	Visited by LMA, Need Geomorph survey for FRAP. Geomorph survey ordered. Owners consents in place.
Story	Owner has had all the details and meeting with LMA. Left to digest, Will discuss further after survey report.

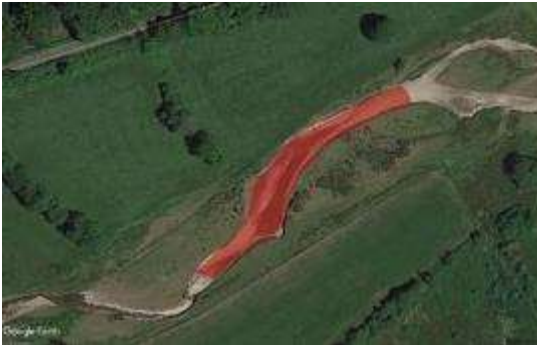
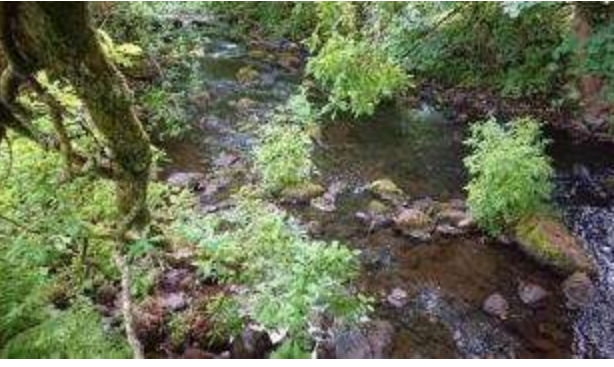
Story	Extraction and introduction consents in place. DCWW stopped proceedings at the final hour. Awaiting further input from DCWW as to progress
Photos Before

Gravel source above reser	Denuded stream below dam

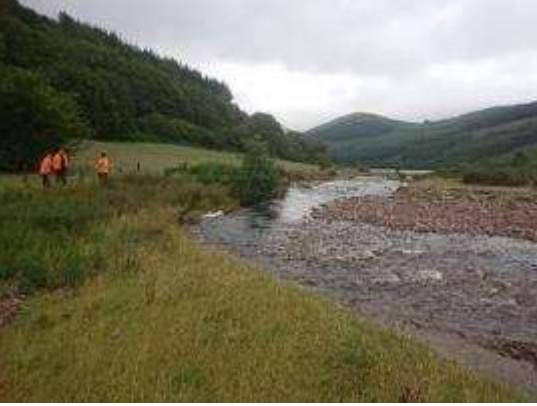
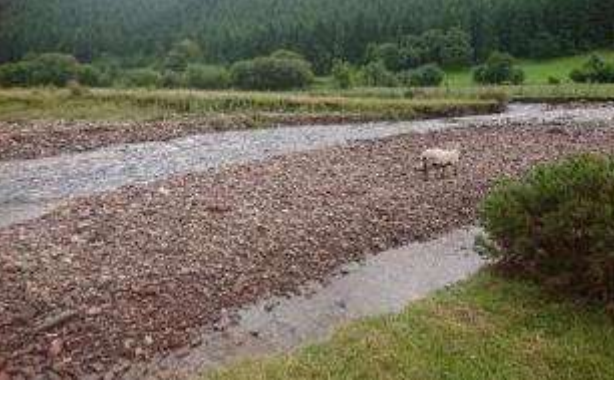
Site visit with DCWW	Gravel source

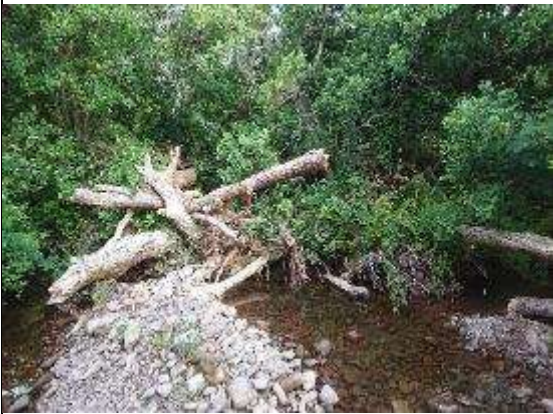
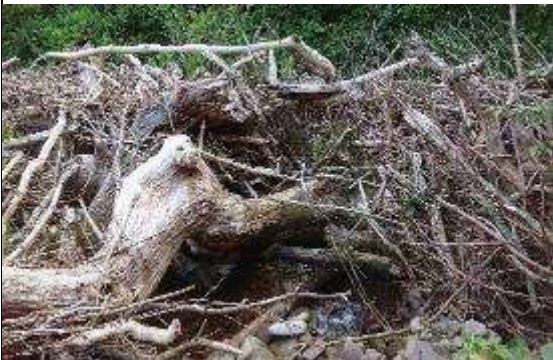
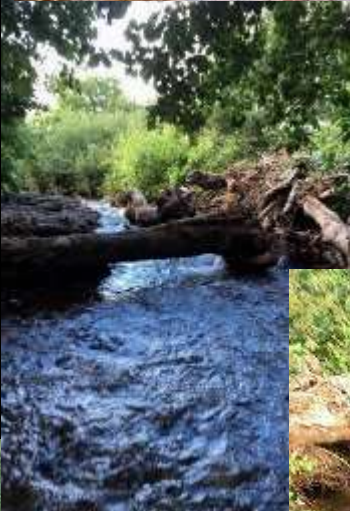
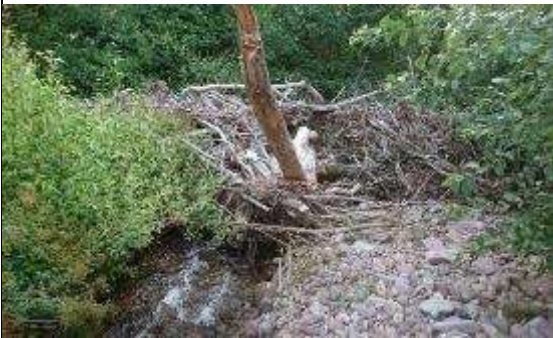
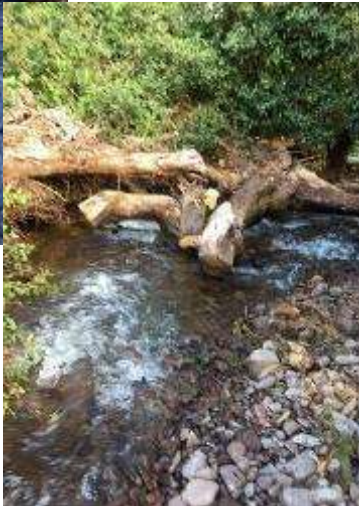
Fish Passage	
Project	Cynrig Debris Dam

NGR	SO 06760 26740	
Action	Completed	
Story	Very large debris dam. Electro fishing showed reduced salmon above. Moyrah Gall (NRW) consented. Took team 2 days to clear	
Photos Before	Photos After

Lessons learned	Remove before similar before it becomes such a problem and needs total removal. If dealt with earlier less erosion would occur and some CWD could be arranged and left in situ.

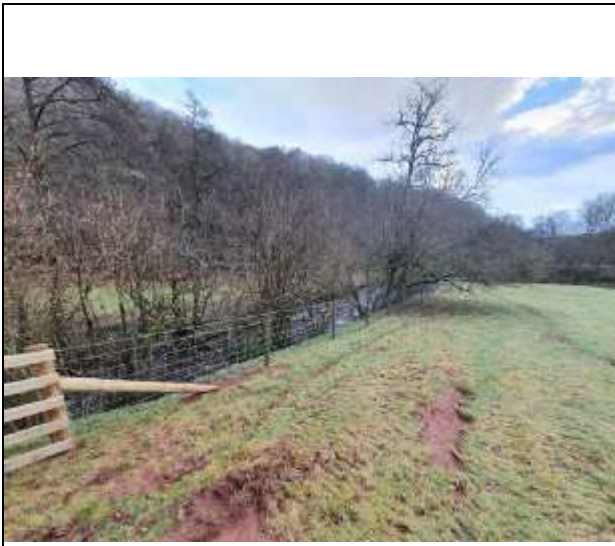
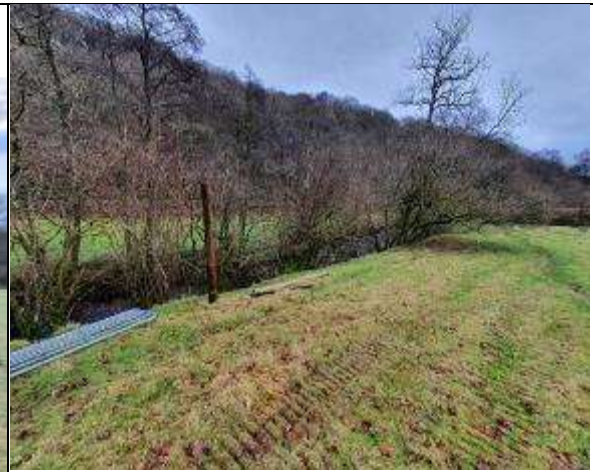
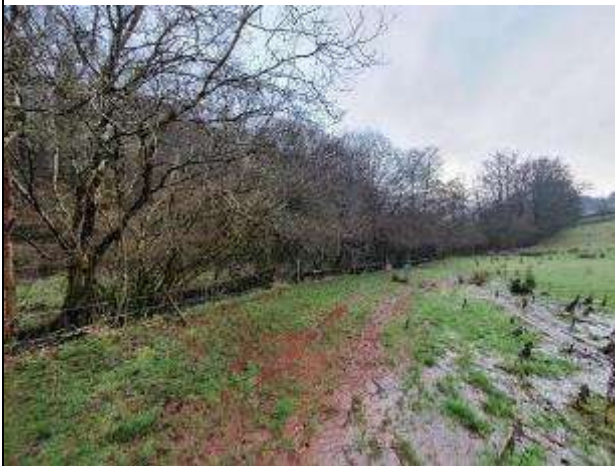
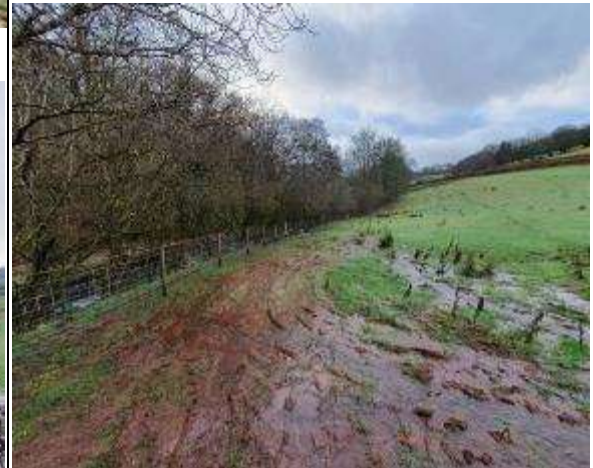
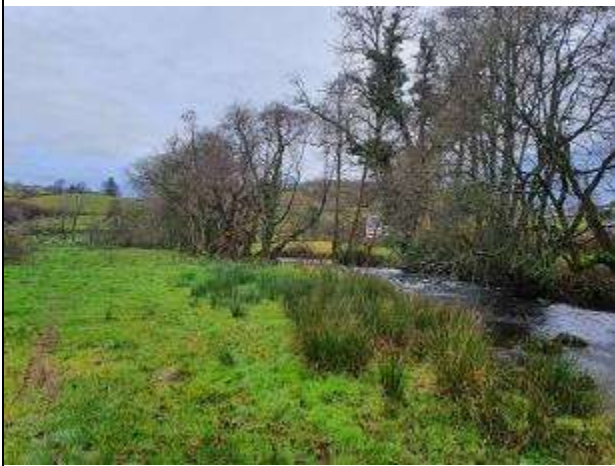
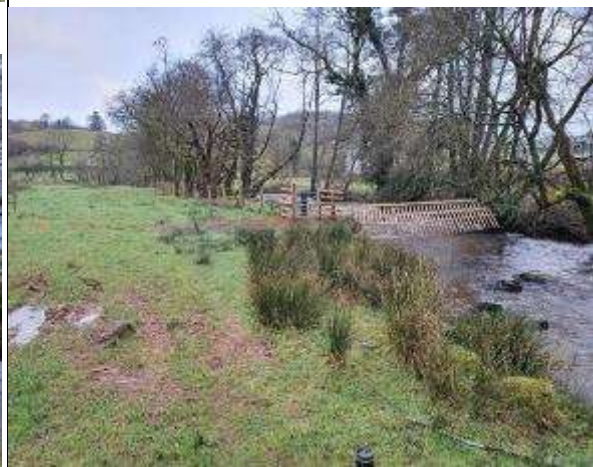
Habitat Restoration	
River	Usk, Bran
NGR	SN 94260 34210
Action	In action

Story	New fence 2337m s/b D/B river enhanced 1743m 7 watergates plus field gates S28 consent 4 owners. Crossed PRoW, gates and consent needed
Photos Before	Photos After

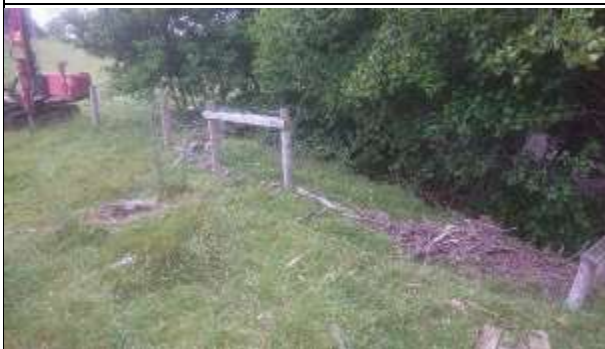
Habitat Restoration	
River	Wye,Llynfi Dulas
NGR	SO 13390 34110
Action	Completed
Story	Repair existing fence- 1400m s/b D/B enhanced – 1000m Existing S28 in place 1 owner
Photos Before

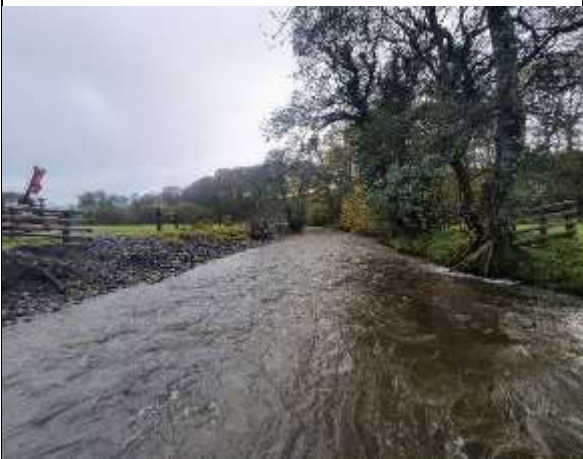
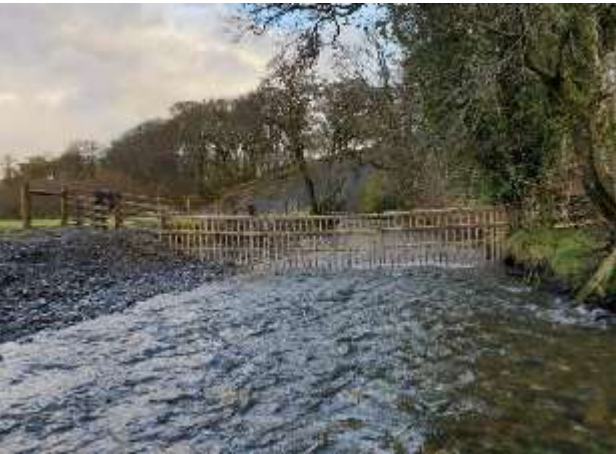
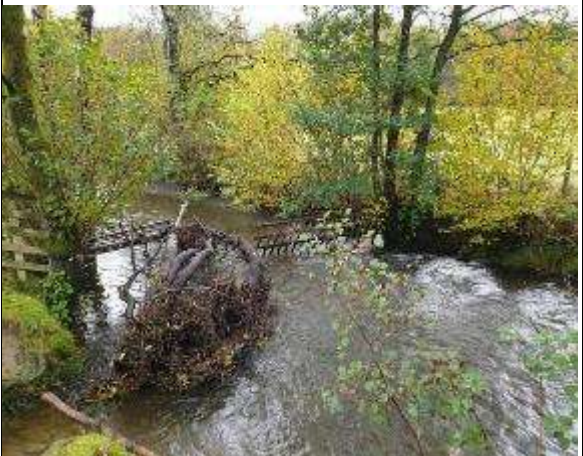
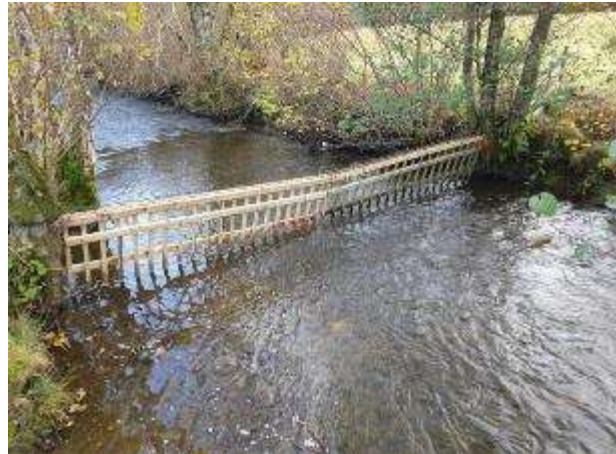
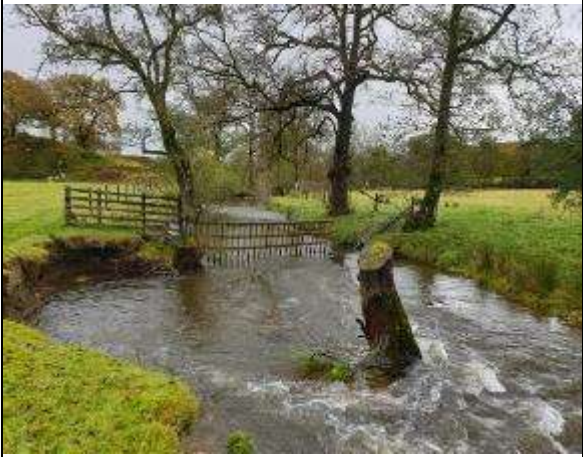
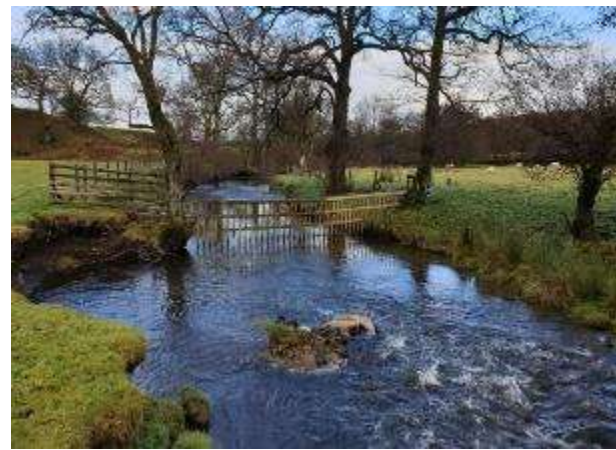
NGR	SN 91200 45950	
Action	Completed	
Story	Repair/replace fence 550m s/b. D/B river enhanced 1900m. 7 Watergates. Existing S28 consent. 2 owners	
Photos Before		Photos After

Lessons learned	Watergates need constant maintenance

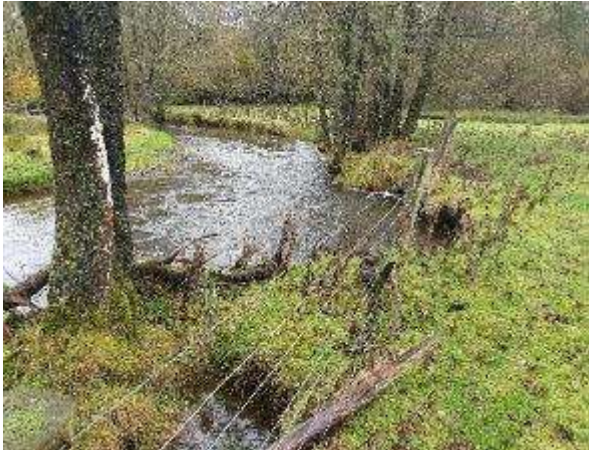
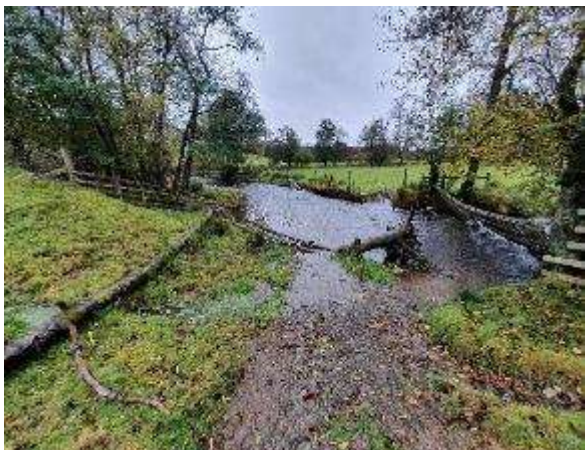
Habitat Restoration	
River	Wye South Dulas Iain Davies
NGR	SN 88690 42710

Action	Consented. Too much to complete in SAF1 continue in SAF2
Story	Repair/replace fence 1100 m s/b. D/B river enhanced 1840m. 7 Watergates. Existing S28 consent.1 owner.
Photos Before

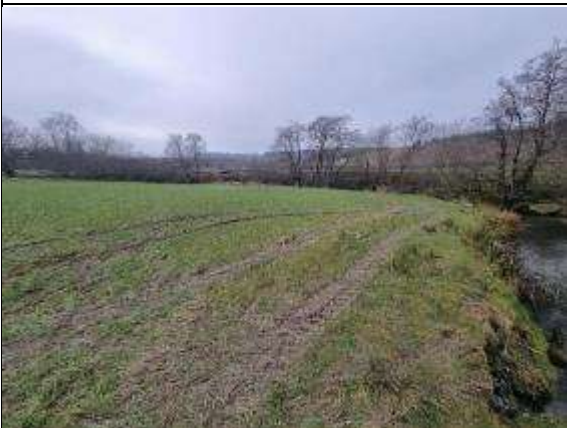
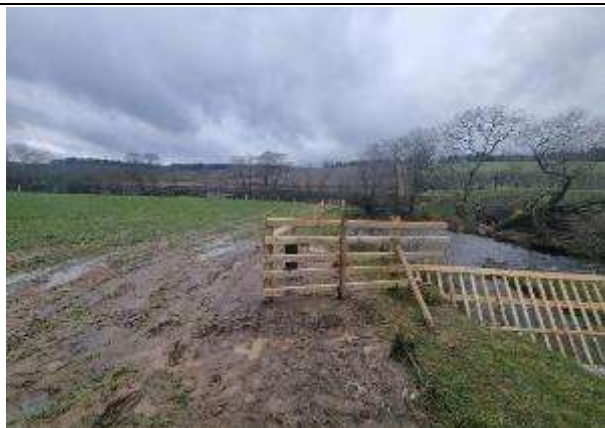
Habitat Restoration	
River	Wye South Dulas Gary Davies
NGR	SN 88690 42710
Action	Consented
Story	New fence 640m s/b. D/B river enhanced 436m. 2 Watergates. S28 consent. 1 owner
Photos Before	Photos After

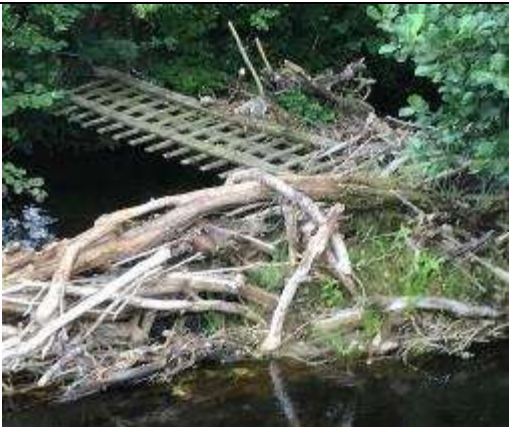
Habitat Restoration	
River	Wye ,Garth Dulas
NGR	SN 94760 52830
Cost	
Action	Completed
Story	Blocked Watergate. Existing S28 consent 1 owner who provided Hymac
Photos Before	Photos After

To be taken
Lessons learned	Watergates need constant checking and maintenance

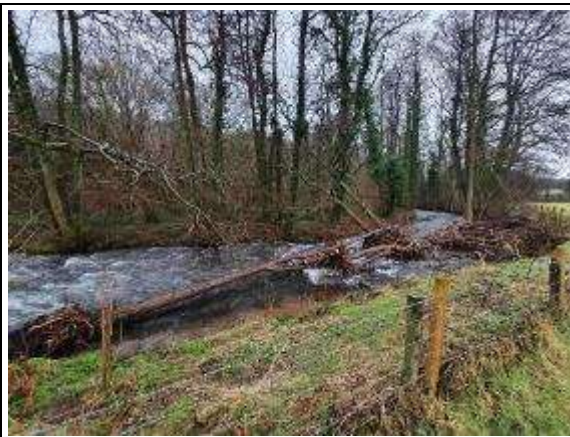
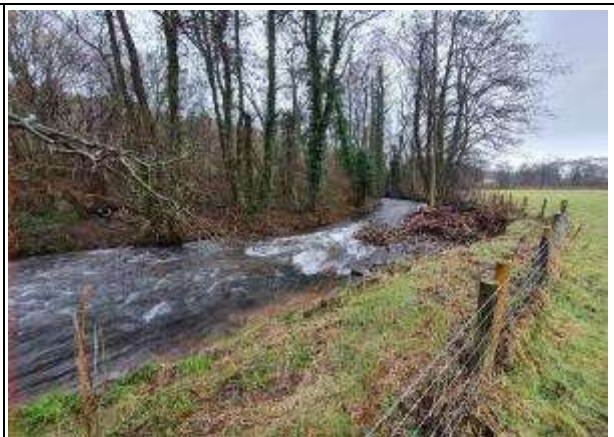
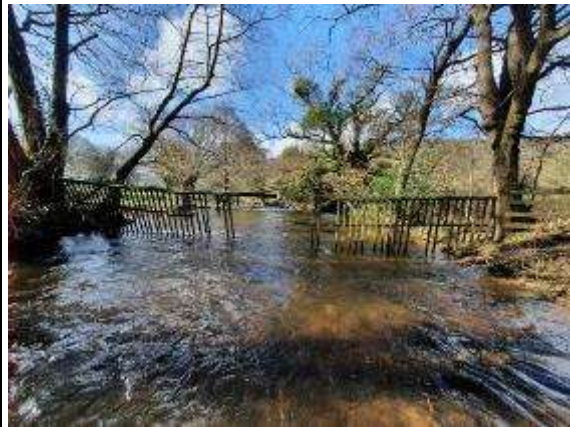
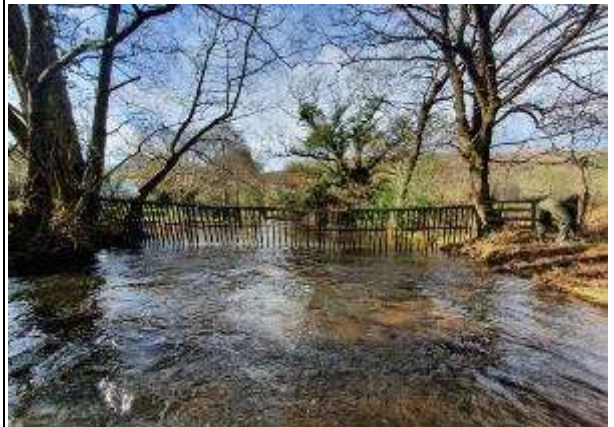
Habitat Restoration		
River	Usk, Grwyne	
NGR	SO 28280 20790	
Action	Consented	
Story	Repair/replace 100m fence. D/B river enhanced 500m. 3 Watergates. Existing S28 consent. 1 owner	
Photos Before		Photos After

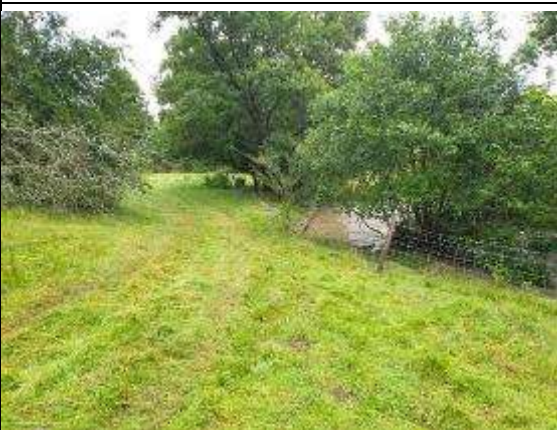
Photos Before

River	Wye Edw
NGR	SO 11640 55500
Action	Completed
Story	Repair/replace fence 650m s/b. D/B river enhanced 1215m. 4 Watergates. Existing S28 consent. 3 owners

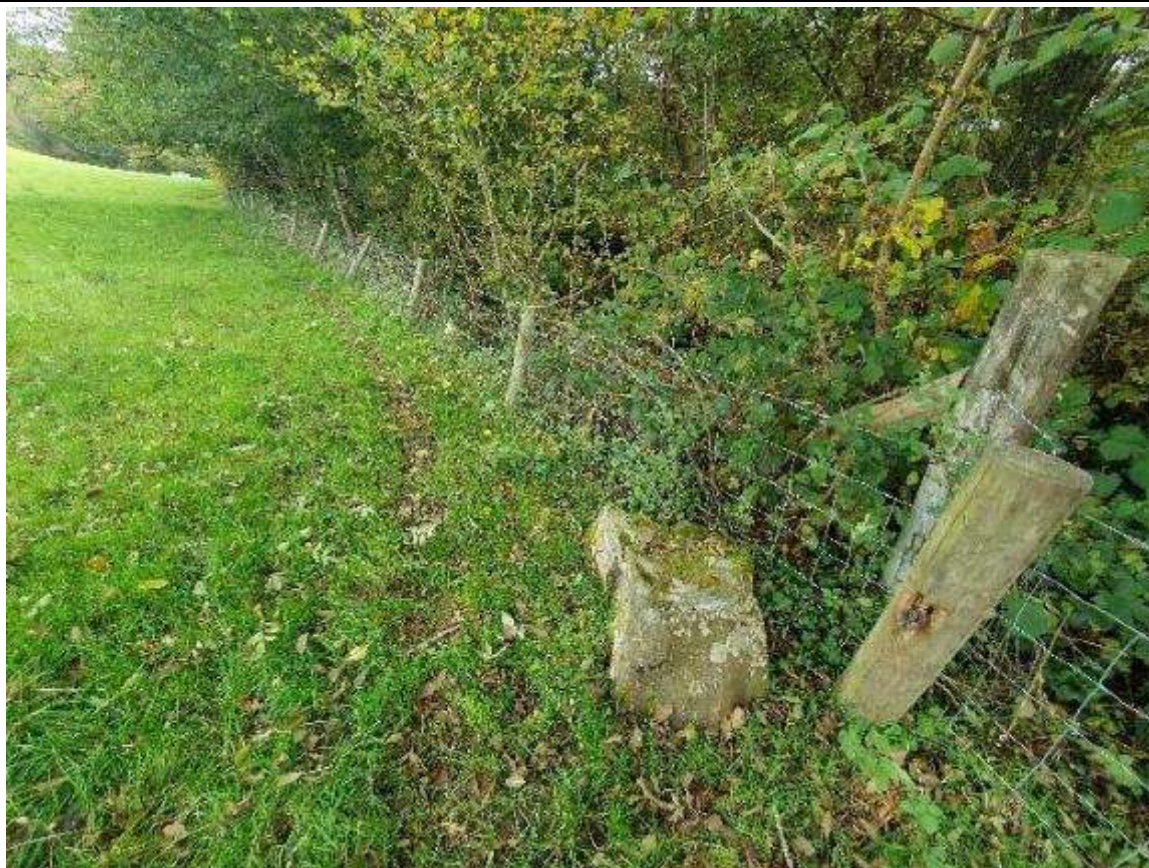
NGR	SN 99100 56900
Action	Consented. Too much to complete in SAF1 continue in SAF2
Story	Repair/replace fence 700m s/b. D/B river enhanced 1021m. 2 Watergates. Existing S28 consent. 1 owner

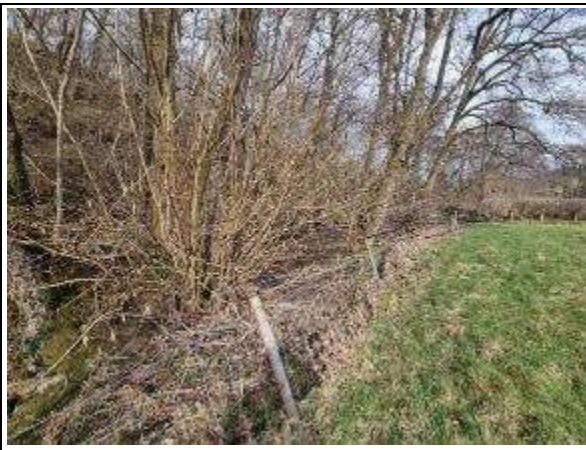
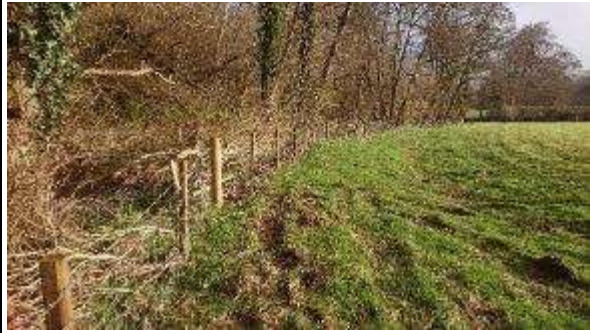
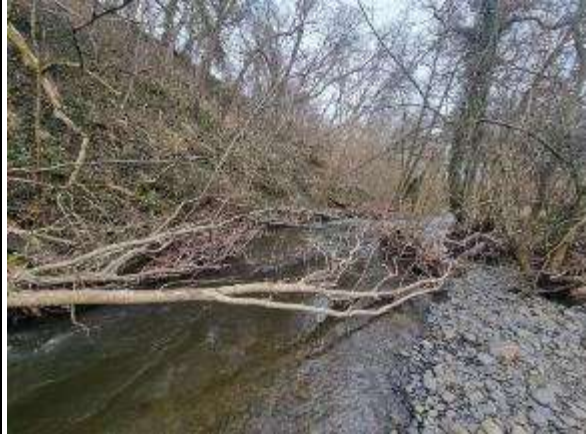
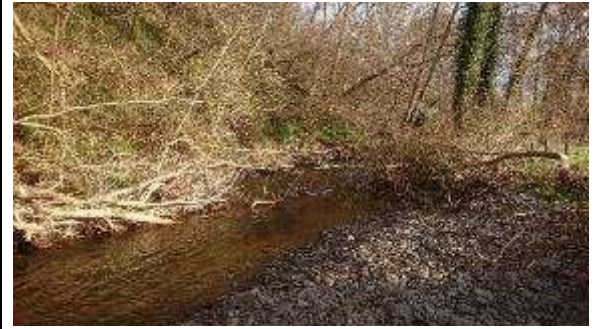
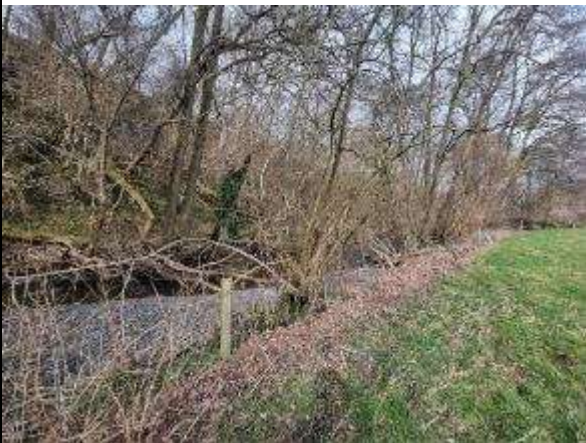
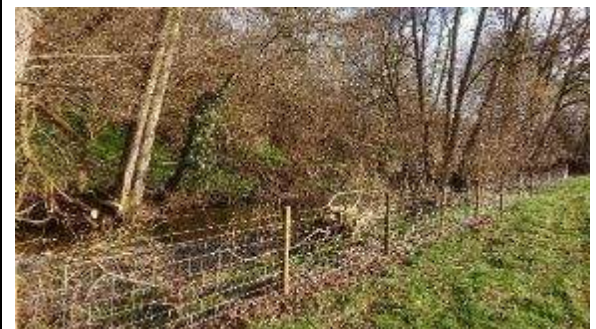
Story	Repair/replace fence 1680m s/b. D/B river enhanced 987m. 5 Watergates. Existing S28 consent. 2 owners
Photos Before	Photos After

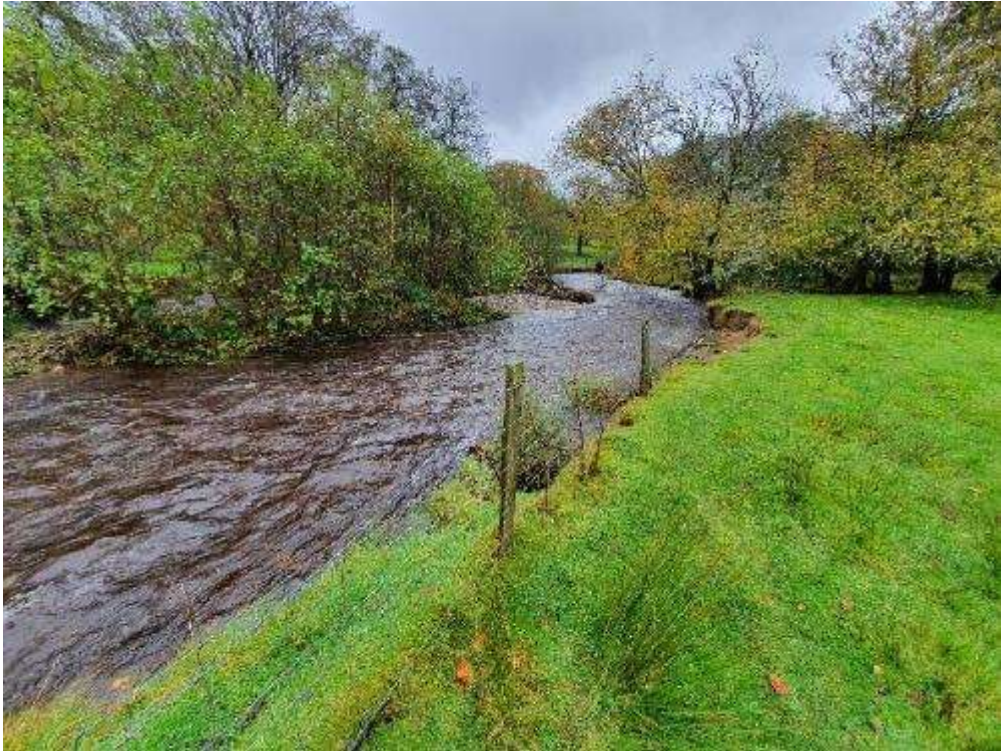
NGR	SN 91090 53330	
Action	Consented. Too much to complete in SAF1 continue in SAF2	
Story	Repair/replace fence 2321m s/b. D/B river enhanced 1450m, 2 Watergates. Existing S28 consent. 1 owner	
Photos Before		Photos

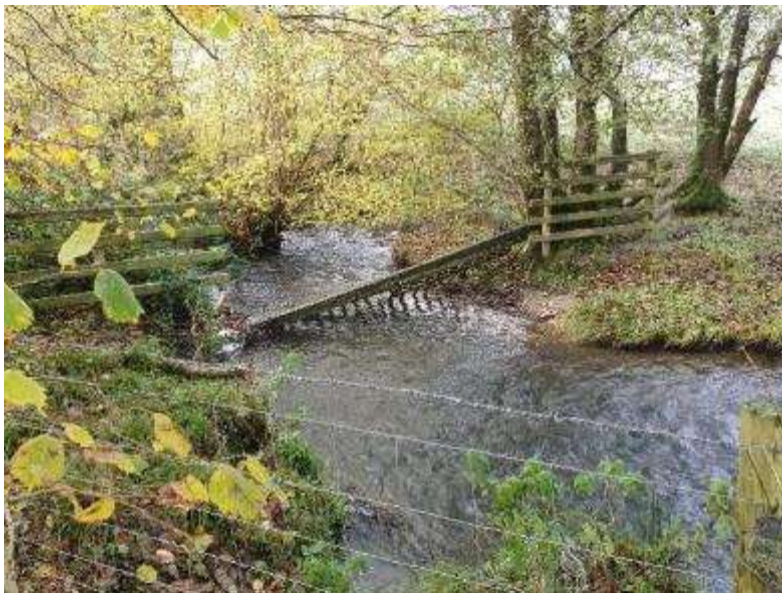
Habitat Restoration	
River	Wye Hafrenna
NGR	SN 97170 50470
Action	Consented. Too much to complete in SAF1,continue in SAF2
Story	Repair/replace fence 50m s/b. D/B river enhanced 1377m. 11 Watergates plus field gates. Existing S28 consent. 1 owner

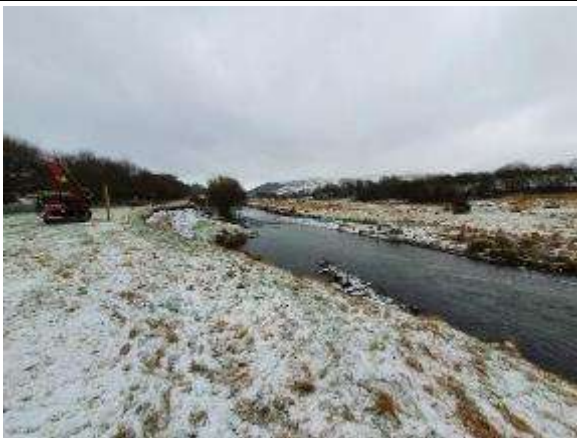
Photos Before

River	Wye Upper
NGR	SN 90130 79720
Action	S28 NRW
Story	New fence 761m s/b. D/B river enhanced 760m. 3 field gates. S28 consent. 1 owner

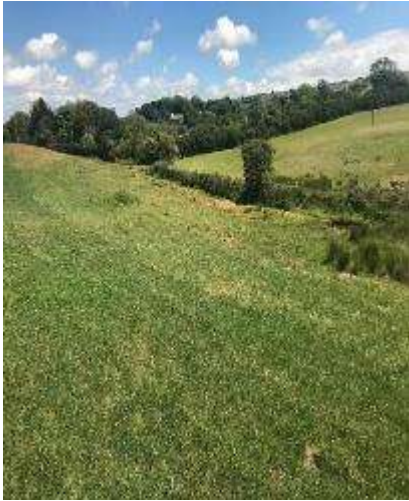
Photos Before

Unfenced LHB. Cattle allowed free access into river throughout. Gates across watercourse at most downstream point which is collecting debris.

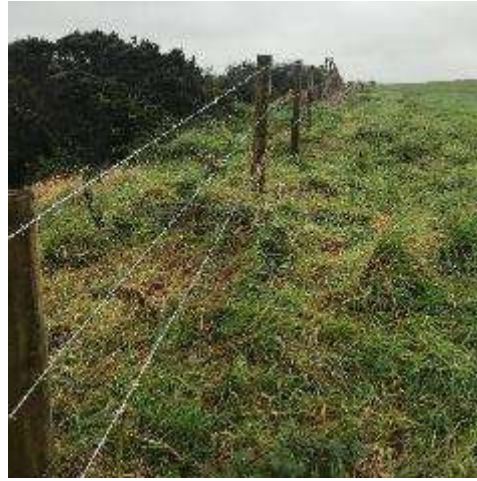
Photos After

Landowner (Martin) keen to fence this field if alternative water offered. Access to mains in top left corner of field. Split into 4 fields for mob grazing when cattle outside.

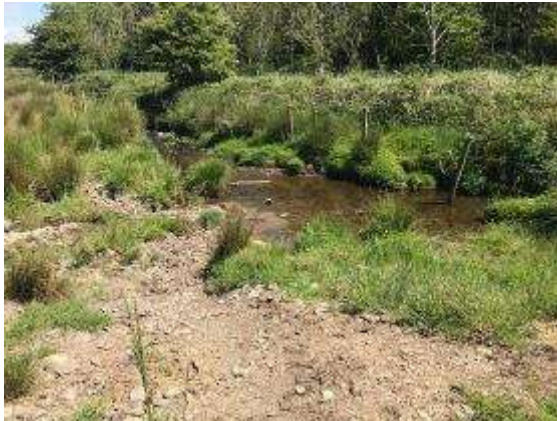
LHB Fenced (3 string). 3 x designated drinking bays. Landowner keen to close off if alternative water option offered. Access to mains. Otter sanctuary on RHB of this field.

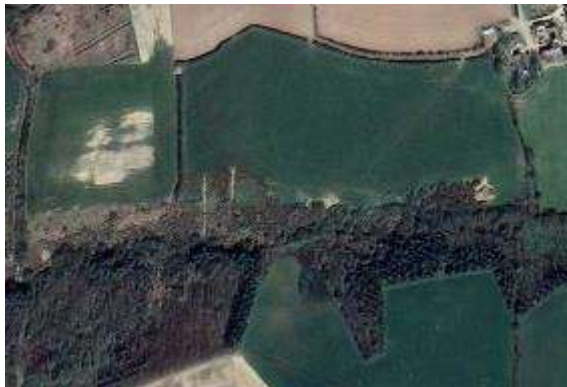
LHB unfenced. Steep bank with good vegetation

cover but stock have free access throughout river and riparian zone. Landowner happy to fence back from the watercourse to encompass the vegetation (5m back from W Cledd). RHB is an otter sanctuary.

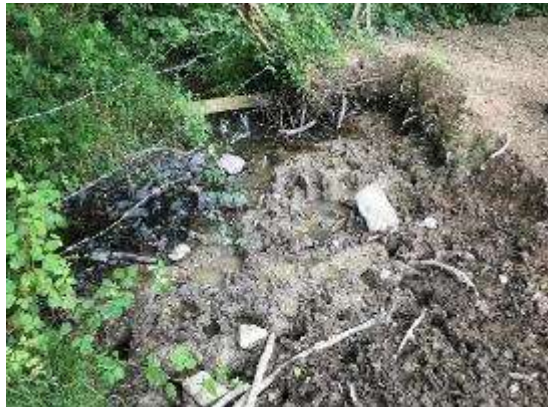
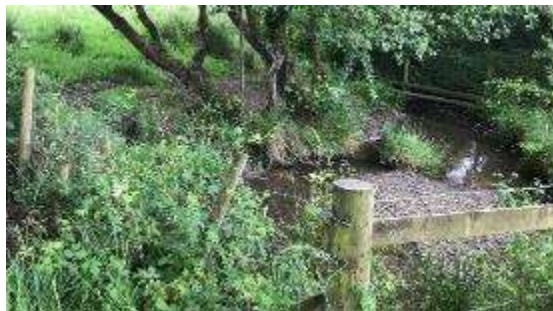
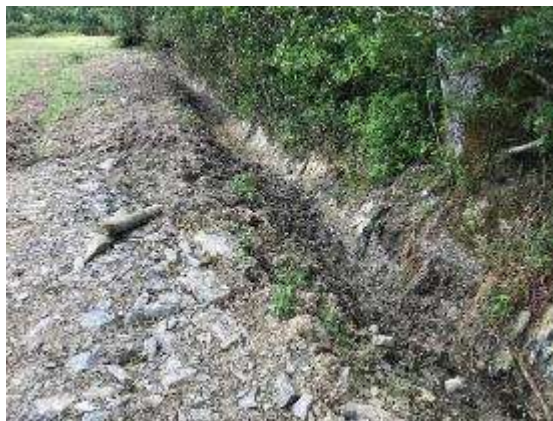
Photos Before

Project	Afon Ceri Cefnmaesmwr Farm
Action	Closing of Stock Access & Well Cleaning (& Piping) for the Provision of Alternative Water.
NGR	SN3260546340
Cost	£11,000
Story	Open stock access throughout ditches and watercourse. Farm identified within the AC/DC project, therefore, has a supporting AC report. Well cleaning and piping to alternative water provisions provided. Stock access to watercourses and ditches removed.

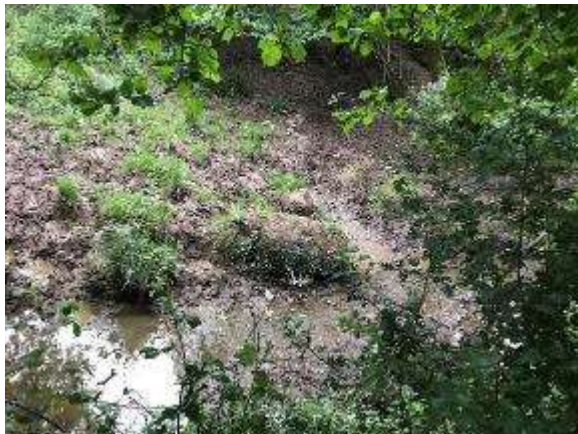
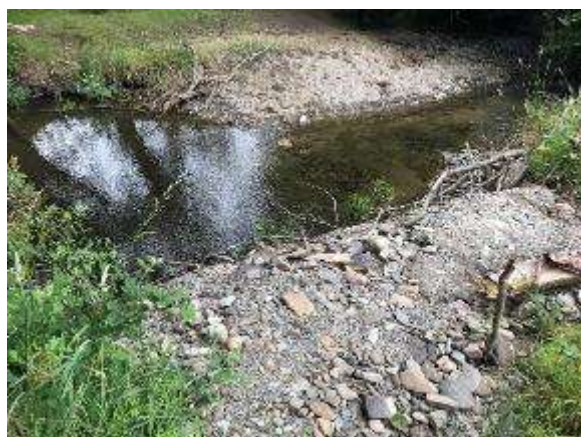
Photos Before

Project	Afon Ceri Field near to Brongest Fishery & Llwyn Cadfor Farm.
Action	Fencing and Provision of Alternative Water
NGR	SN3217145526 & SN3395342694
Cost	£5,000
Story	Open stock access in field adjoining fishery, trampled ditches. Fence field and offer alternative water option. Llwyn Cadfor Farm Fence and alternative water for stock.

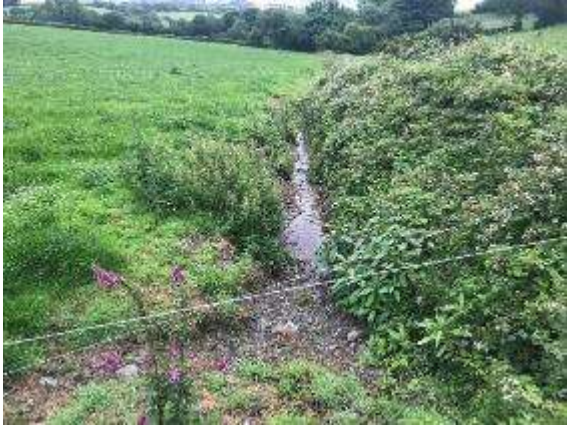
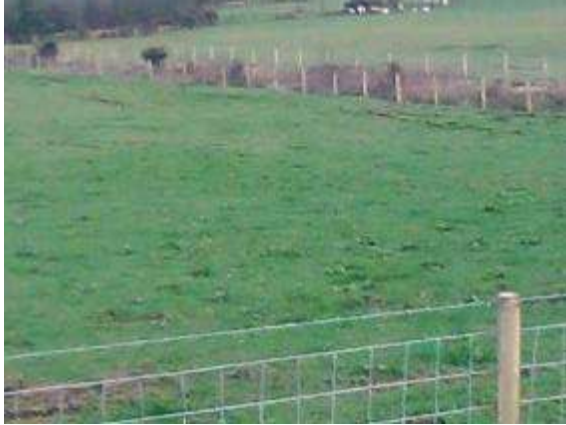
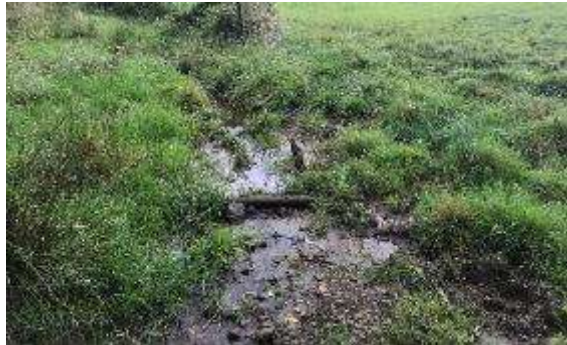
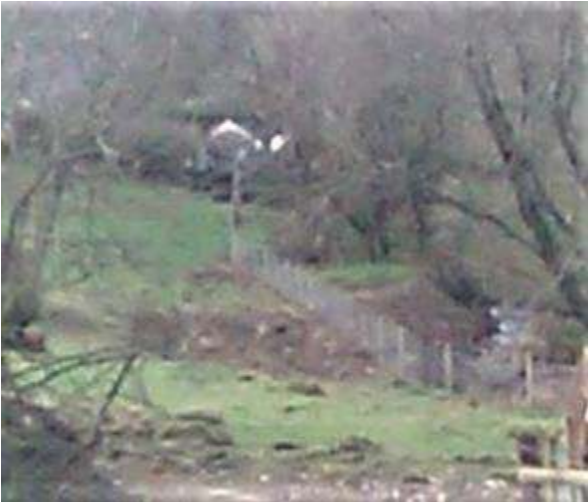
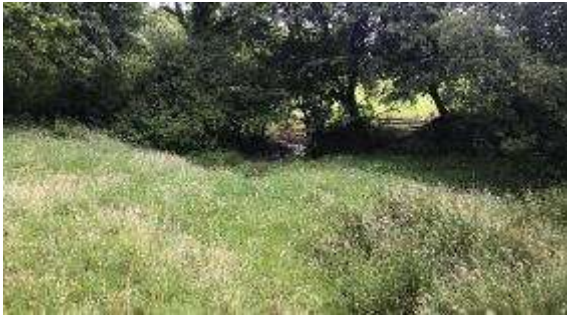
Action	Fencing and Provision of Alternative Water	
NGR	SN3716048160	
Cost	£5,000	
Story	Open stock access throughout ditches and watercourse. Farm identified within the AC/DC project, therefore, has a supporting AC report.	
Photos Before		Photos After
