Fisheries Habitat Restoration Project

Final Report 2020-2021

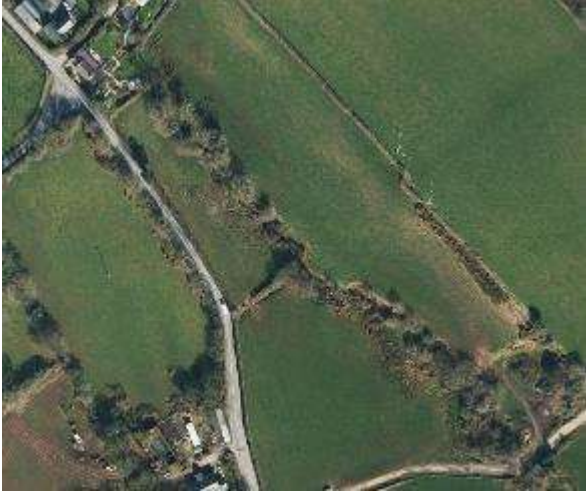
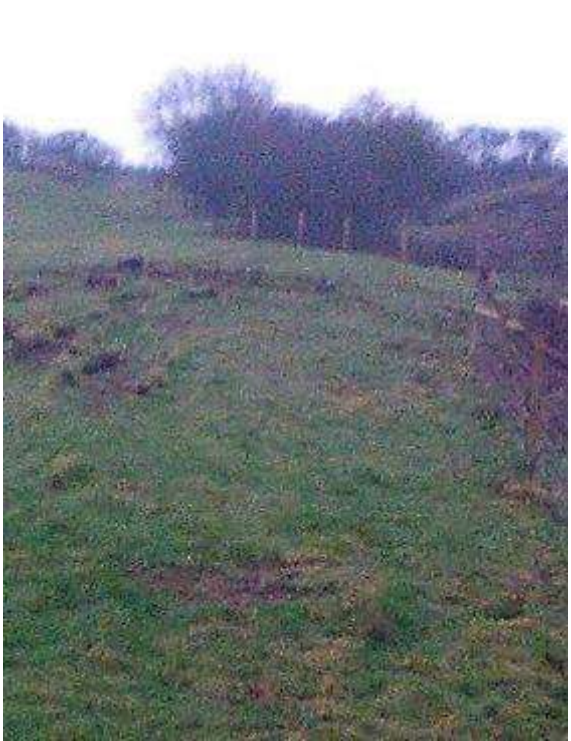
Action	Fencing and Provision of Alternative Water	
NGR	SN3727651279	
Cost	£4,455	
Story	Double fence ditch / stream running through field & alternative water	
Photos Before		Photos After

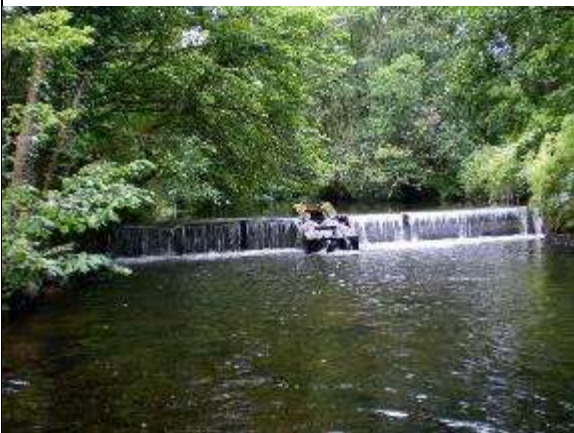
Fish Passage	
Project	Vicars Mill, Eastern Cleddau
NGR	SN 10623 22547
Cost	£38,844.50
Action	Demolition of 70% of the weir & removal of old fish pass.
Story	Removal of the structure will improve access to more than 20kms of upstream fish habitat and restore the natural river geomorphology. Work to dismantle the weir and fish pass began on 1 September 2020 and was carried out by an experienced local contractor who completed the task in just three days.
<div> <div> Photos Before

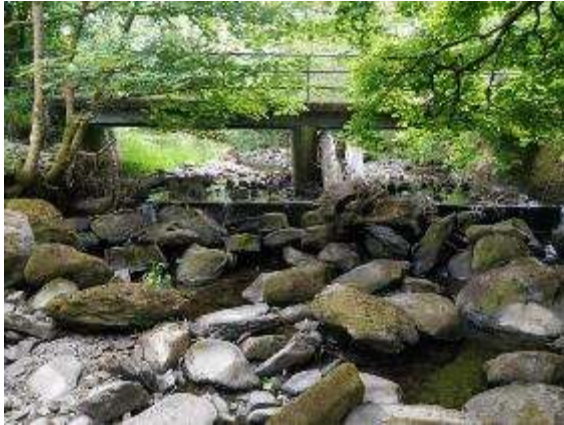
Photos Before

Fish Passage	
Project	Afon Clywedog, Teifi
NGR	SN 63044 51090
Cost	£12,199.00
Action	Larinier style fish pass
Story	Easement of a substantial concrete weir (sill) used to support a road bridge leading to a private house. There was no pool immediately below the weir and only a shallow one some distance from it, limiting the potential for fish to traverse the head height.

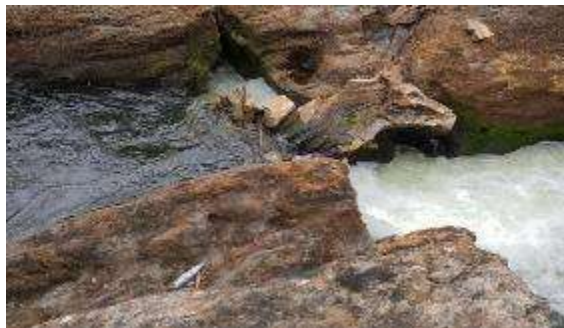
Photos Before

Project	Teifi at Henllan gorge
NGR	SN 35859 40105
Cost	£1,800.00
Action	Removal of a log blockage from the narrow low flow channel
Story	The location of the tree blockage had been impeding fish passage at low flows for a couple of years and previously dead fish had been found on the surrounding rocks (see photo below) where they had jumped but failed to clear the obstruction.

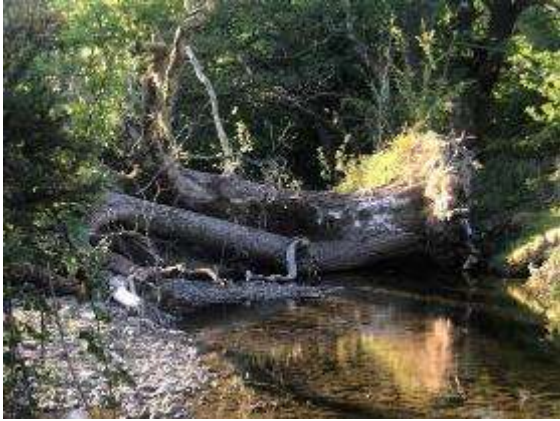
Project	River Mynys
NGR	SN 73285 32824
Cost	£411.80
Action	Removal of large fallen Oak tree causing a blockage to fish passage and installation of 23m of stock fencing
<div> <div> Photos Before

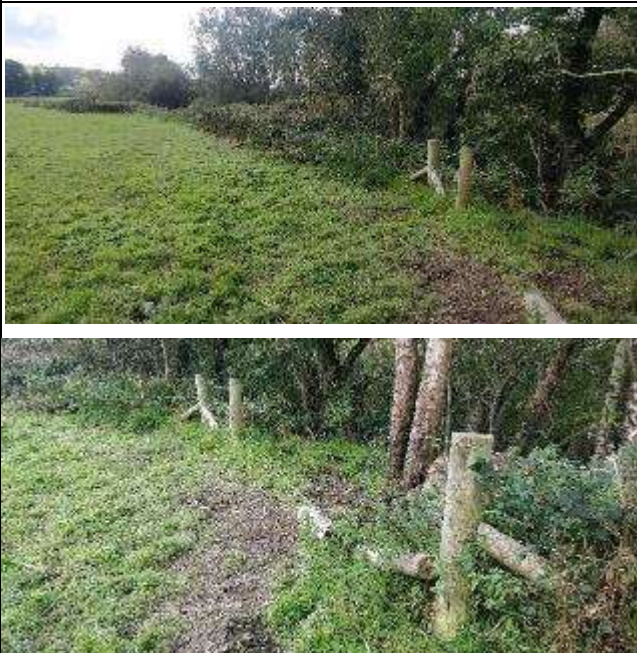
Habitat Restoration	
Project	Rhosmaen Dulais confluence (Clos Glas)
Action	Fence off 1 x drinking bay and install solar powered pump & trough - others to follow based on owner evaluation of this one. Maintenance of approximately 160m of existing fencing.
NGR	SN 39412 36980 to SN 64703 23989
Cost	£1194.00

Story	Repairing fencing previously installed over 15 years ago. Good buffer strip in place which is worth protecting by fixing existing fencing.	
Photos Before		Photos after

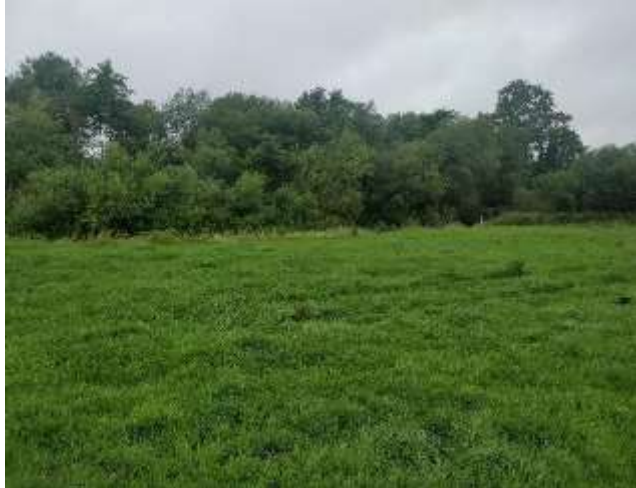
Habitat Restoration	
Project	Tywi Dolau Gleision on the Rhosmaen Dulais
NGR	SN 64488 25421
Action	The biggest phase of this project, the replacement of existing failing fencing over approx. 0.76km, has been completed and was reported on in October. However, there is a small (90m) section of fencing still to be completed in spring 2021.
Story	This section is on a river bend with eroding banks and so in December 2020 WWRT staff will be planting willows to stabilise the section prior to the fencing being installed.
Photo before	Photo after

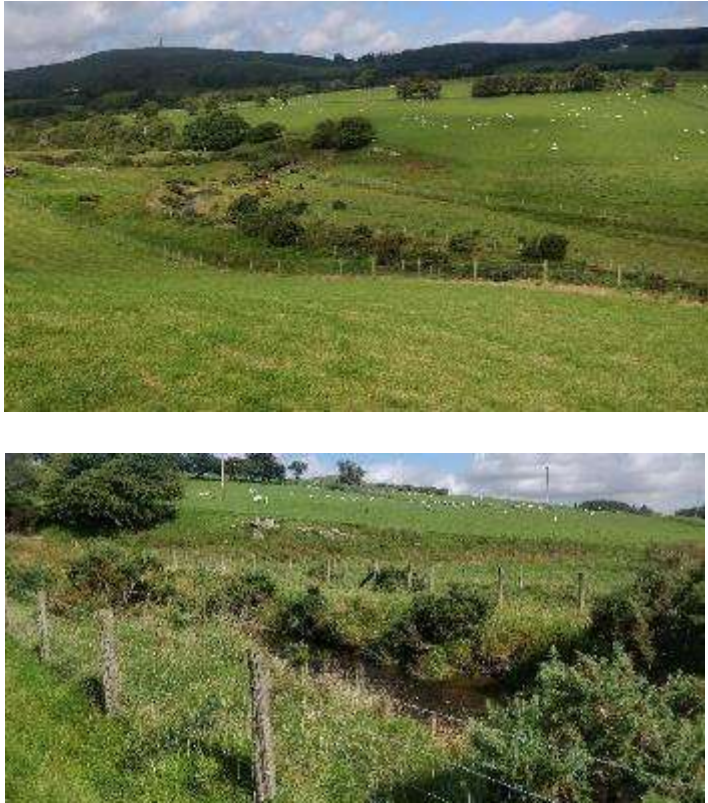
Habitat Restoration	
Project	Teifi River Meurig
NGR	SN 72011 68225 to SN 71823 67784
Action	This is a scheme in the upper reaches of the river Meurig. The scheme involves the fencing of several fields, and the installation of water gates and solar powered pumps and troughs. The fencing will extend for approx. 1km along both banks.
Story	Previous NRW scheme. Posts replaced where necessary and small fallen section. Double bank - Maintenance repairing old scheme. All strainers gone and three quarters of posts rotted needed replacing. Plus new swing gates at ends of scheme that were also damaged.
Photos Before	Photos After

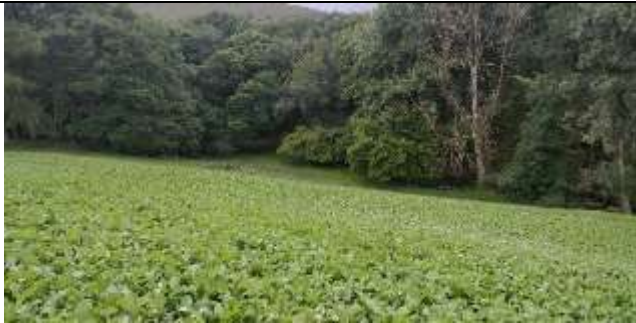
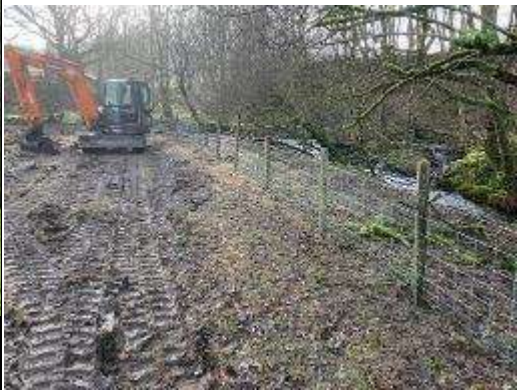
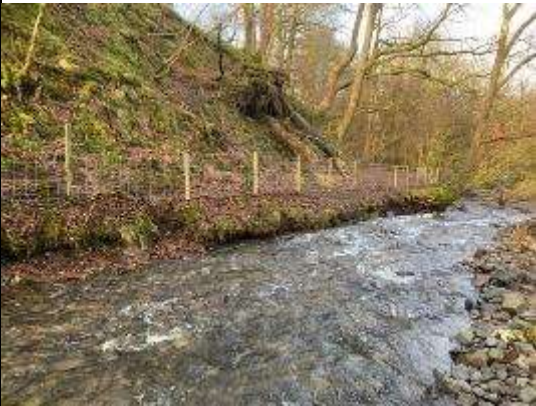
Action	<p>This scheme extends for approx. 300m and is along a currently unfenced section of the Nant Carfan with unrestricted cattle access to the river. There is an ash tree that needs to be removed and as alternative drinking is already present the installation of the fence will achieve total stock exclusion.</p>	
Story	<p>This scheme extends for approx. 300m and is along a currently unfenced section of the Nant Carfan with unrestricted cattle access to the river. There is an ash tree that needs to be removed and as alternative drinking is already present the installation of the fence will achieve total stock exclusion.</p>	
Photos Before		Photos After

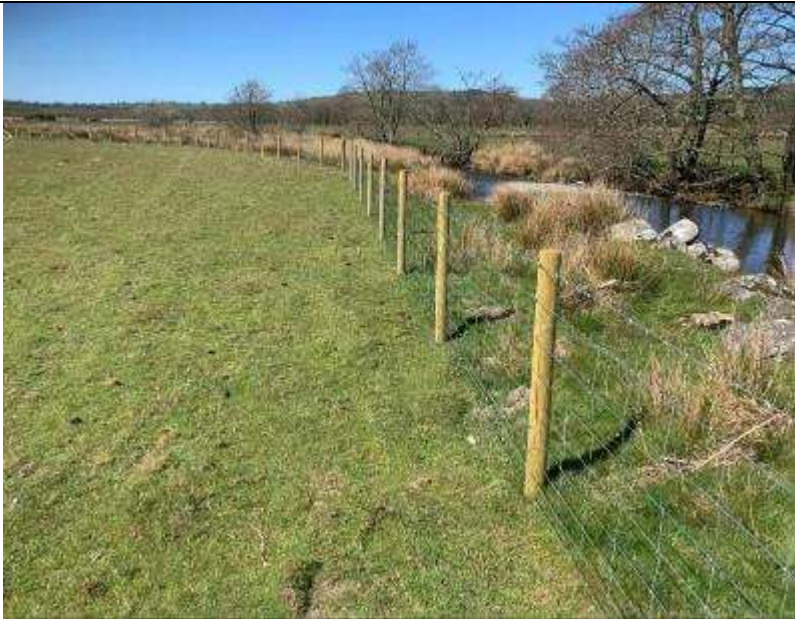
Habitat Restoration	
Project	Teifi main stem
NGR	SN72146 66783 to SN71705 66664
Cost	£7,626.00
Action	0.875km
Story	New double bank fencing scheme. High tensile sheep netting with one strand top barb. Plus 3 gates.
Photos Before	Photos After

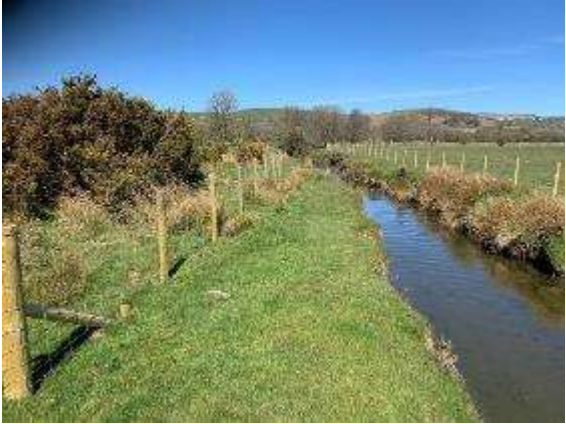
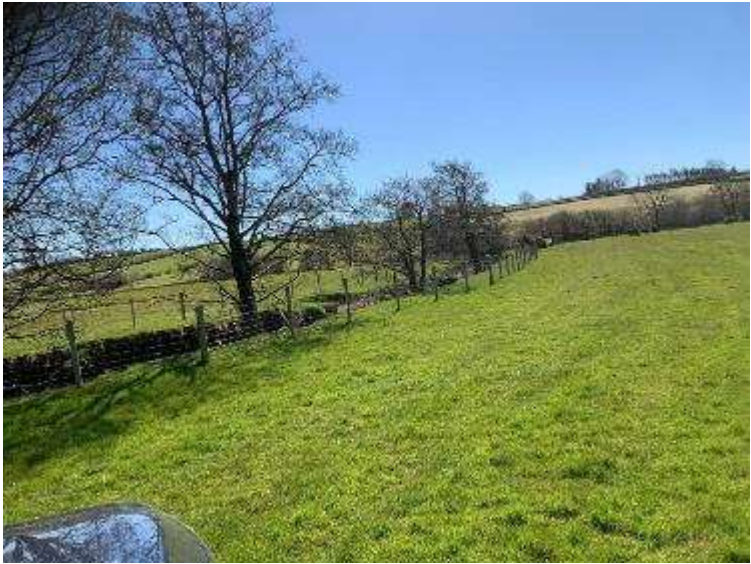
Habitat Restoration		
Project	Meurig	
NGR	SN71787 66903 to SN71831 66754	
Cost	£1,548.00	
Action	0.16km	
Story	New fencing – single bank	
Photos Before	Photos After

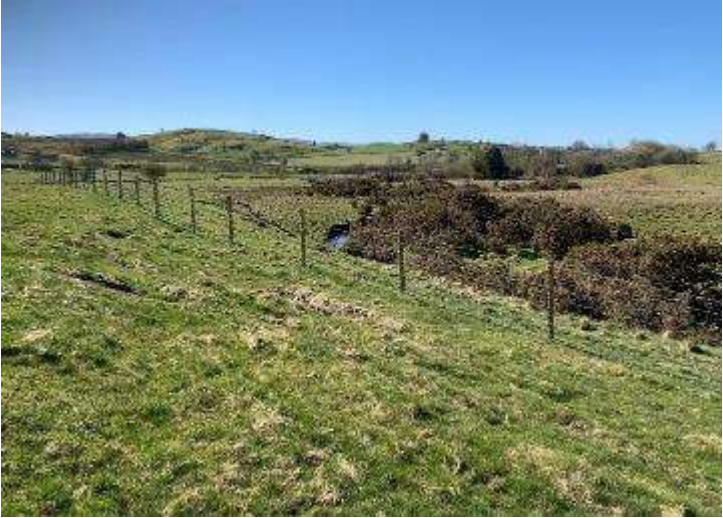
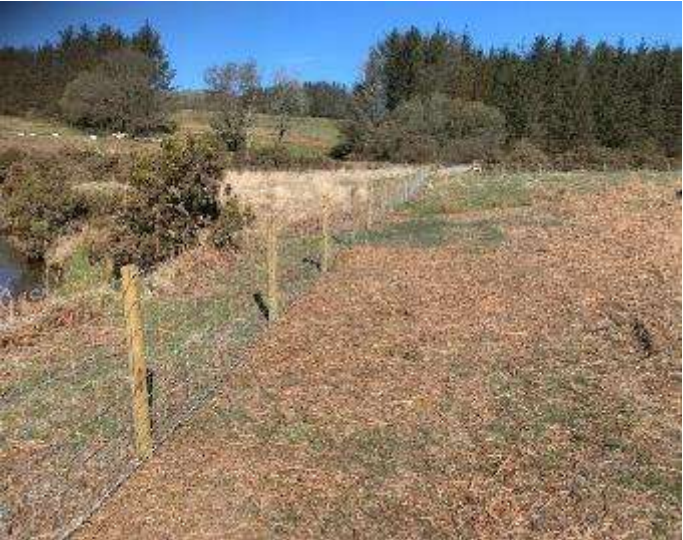
Habitat Restoration	
Project	Meurig
NGR	SN72801 69308 to SN72757 68750
Cost	£7,915.20
Action	0.8km
Story	LHB. Replacement fencing. Combination of barb and sheep netting. Three 12ft gates and one footpath gate.
Photos Before	Photos After

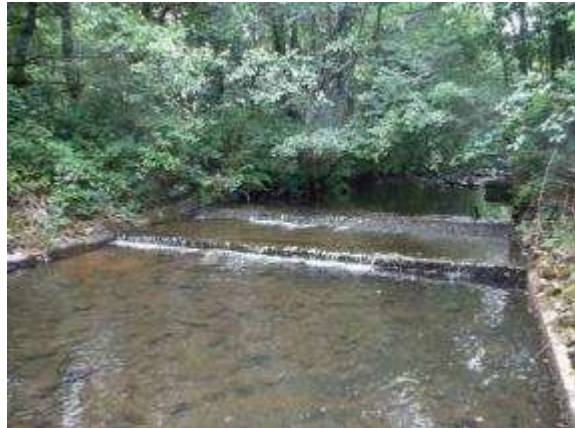
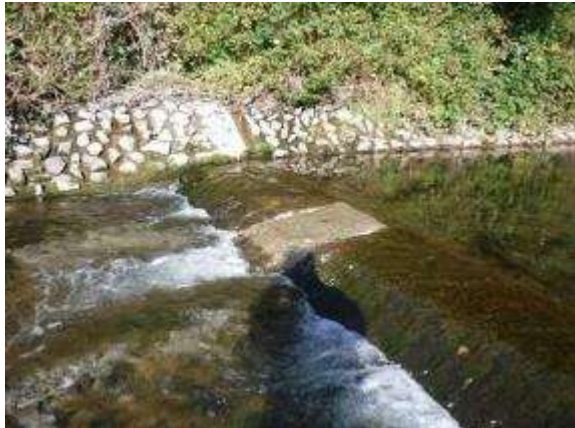
Project	Taff Bargoed climbing centre weirs
NGR	ST 10140 99620
Cost	£1,716
Action	Notch a series of 5 small concrete double weirs spread out along approximately 300metres of a canalised section of the river
Story	The site is now the Welsh international climbing centre but was formerly the offices of the Taff Merthyr Colliery. Through this section the river was constrained within a concrete channel to prevent erosion into the mine site. Over time the concrete bed of the channel has been covered by river gravel washed down and to all intents and purposes is a natural bed. However, the 5 double step weirs remained as a series of obstructions. These have been notched using petrol disc cutters and kango hammers.
<div>

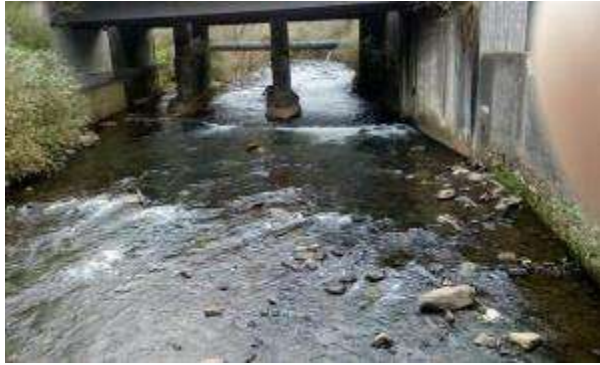
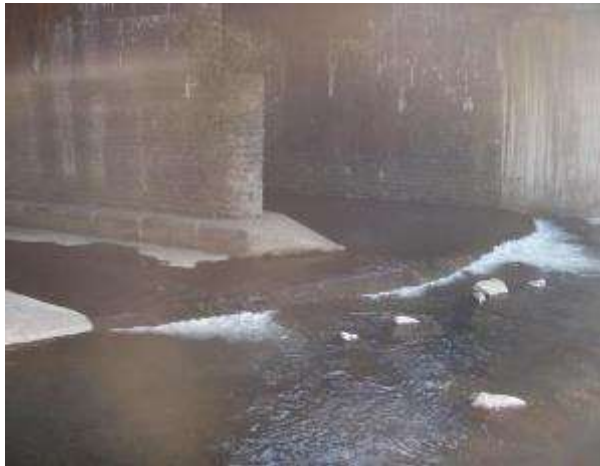
Before photos

Fish Passage	
Project	Trehafod railway bridge
NGR	ST 04300 91115
Cost	£5,556
Action	Fixing 10 timber baffles to the concrete floor of the Trehafod railway bridge
Story	Barrier to fish passage at some flows. There were three distinct channels forming the barrier Recommended by Natural Resources Wales to install wooden baffles in channel on the left-hand side facing upstream. At this time the flows were even between two channels. Storm Dennis changed all this by making the left channel the main one. This would have resulted in any baffles being subjected to any debris large or small coming down the river that could have damaged them. It was noticed that on the flows when migratory fish would be expected to run the centre channel offered a better solution. It was decided to go with this option

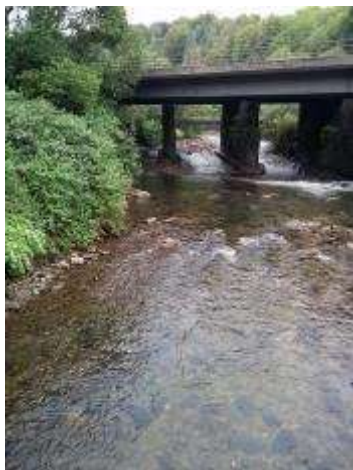
The picture (top left) shows the channel before work started with a small flow. The shoal above was mostly removed and the two pictures below show how it works on high water. Our experience shows that the thing with baffles is that trees can break them free. The outer channel on the left. Will be the one that any trees will be pushed towards as the stronger flow.

Action	Fixing 10 timber baffles to the concrete floor of the Trehafod railway bridge
Story	Trehafod railway bridge like many in the Valleys has a large anti scour pad cast on the riverbed between the abutments to prevent undercutting of the bridge this pad extends some 15 metres along the stream and is full width. Originally the plan had been to locate the baffles in the Left channel, lower picture. However, following the floods of February 2020 and the resultant regrading of the bed the centre channel offered a better solution. This decision was also based on previous experience. Contractors fixed the baffles under network rail site supervision

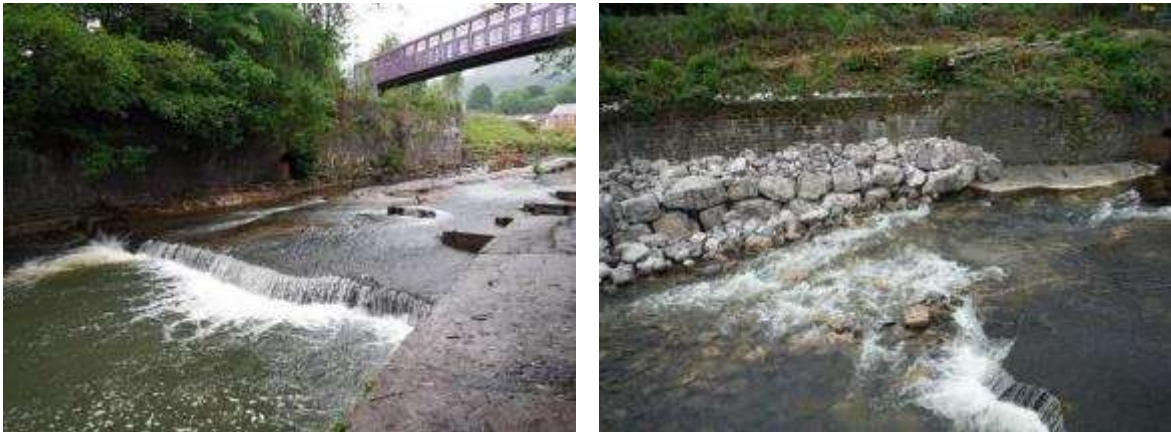
NGR	ST 05140 98765
Cost	£ XXX removal of damaged baffles
Action	Downstream blockstone placement to flood out weir step
Story	<p>Mountain Ash weir is the remains of a railway bridge scour pad it is approx. 35 metres in length with a 1m downstream step, the scour pad had baffles fixed to it previously. However, during the extreme flooding of February 2020 these were extensively damaged. Later in the spring the remaining damaged baffles, anchor straps and bolts were removed to prevent H&S risks to river users.</p> <p>Later we were informed that RCTCBC would be carrying out significant repairs to riverbank revetments in the area both above and below the weir using block stones including the use of a block stone roadway to get down to the weir to carry out repairs in the downstream section. Following discussions with the council engineer it was agreed that some of the block stone roadway below the weir would be used to create a prebarrage once works downstream were completed. This was carried out a zero cost to SEWRT except for the officer time involved in the discussions and site monitoring.</p>

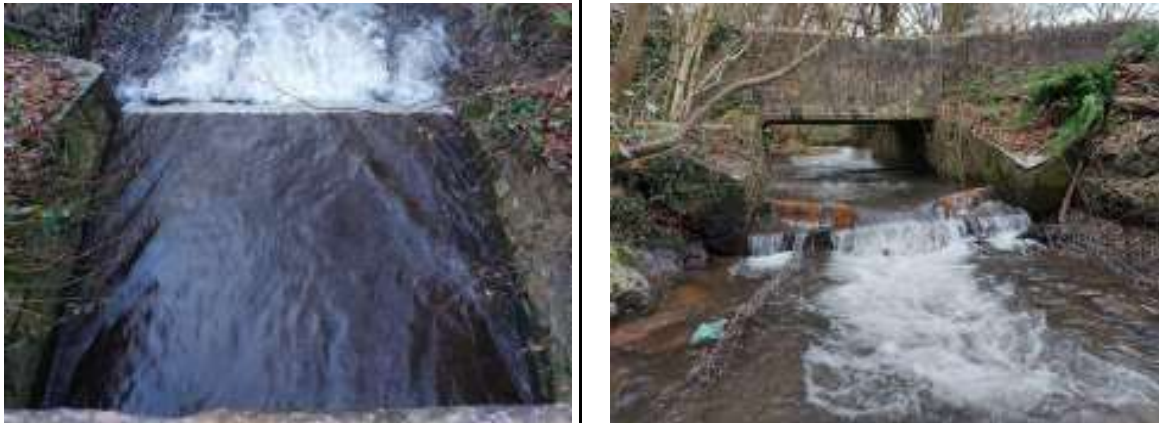
Cost	£4,436 plus materials £2,727
Action	Installation of Baffles
Story	<p>The Nant Glandulais runs into the River Rhymney where the A48 crosses the river. A culvert runs under the Hawthorns Footbridge which is causing a barrier to fish migrating upstream. The culvert creates shallow and fast water which makes it difficult for fish to pass through it.</p> <p>The installation of baffles both upstream and downstream of the culvert aims to slow the water, increasing the water's depth and creating diverse flows. This will be done by installing timber baffles which will be held into place by steel brackets which will be screwed into the concrete. We plan The installation of one timber baffle on the upstream side and two on the downstream side. Each baffle will be made up of two 1.4m long timbers alongside each other with a gap of 30cm in between them. These will each be held down by two steel brackets.</p>

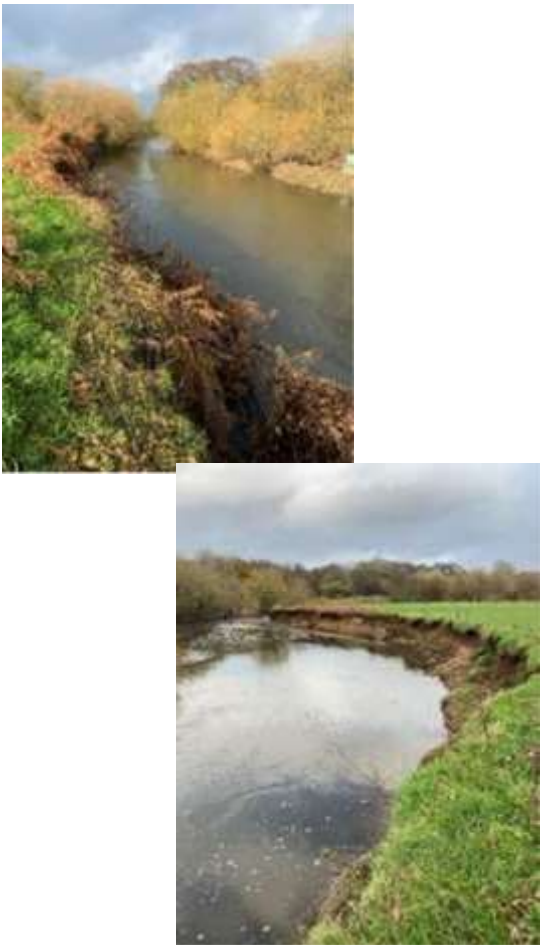
Story	<p>The Bryn is a stock farm on the outskirts of Pendoylan. The land adjacent to the river has over time eroded away, up to 10m has been lost over the last 15 years, this includes the original fence which is in the river.</p> <p>There is also some poaching from cattle present. The objective was to erect a fence to prevent stock entering the river and to let some vegetation grow to help stabilise the banks.</p> <p>We would hope to revisit this area in the spring to see if we can limit the erosion by putting in some strategic deflected that have worked for us in the past</p>
Photos Before

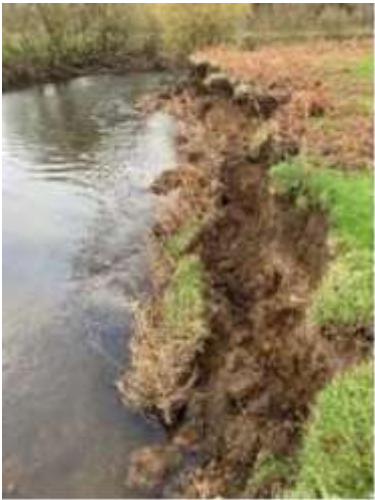
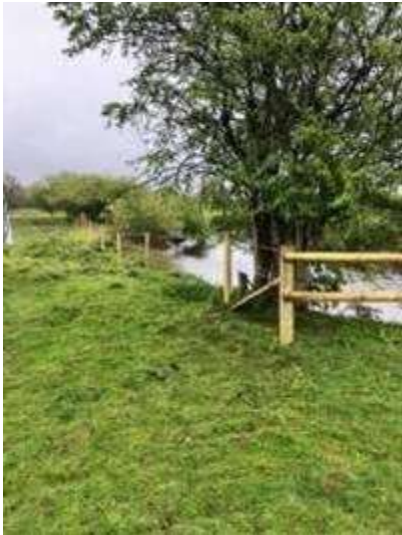
Photos After

Lessons learned	<p>We used a combination of different types of fencing, depending on where the river flooded. In areas which flooding was significant we used three strands of barb to allow water and debris to flow through. In areas which the flooding risk was lower we used stock netting and barb.</p> <p>This combination of fencing has helped to reduce the pressure on the fence which flooding can cause and therefore protecting the site and fence for the future.</p>

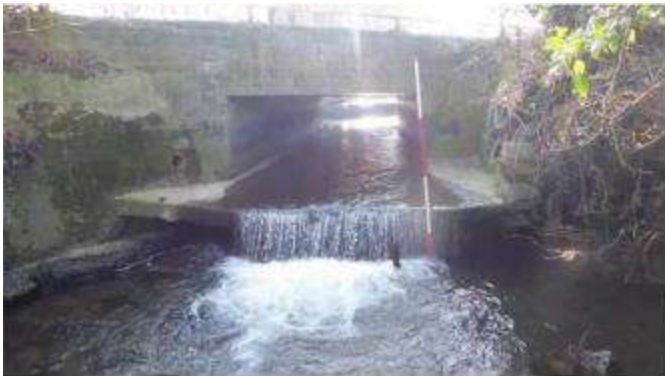
<p>Barrier at Sarn on the Caebitra</p>

Action	Complete designs for fish passage projects at four sites on the Cledan, Llifior, and Caebitra (x2)	
NGR	Four sites - SH 99739 06514; SO 19570 98628; SO 23485 92823; SO 20891 90903	
Cost	£67,387	
Story	<p>Four impassable barriers for fish migration were prioritised and selected by the Severn Rivers Trust and Natural Resources Wales to consider for Assessment and full Options Appraisal and to then move to Detailed Design and stakeholder engagement. An open tender resulted in Fishtek Consulting being appointed to undertake this project.</p> <p>The Options Appraisal has been completed and Detailed Design is underway. Future engagement into 2021/22 has been agreed to take the projects forward to ensure stakeholder buy in, Early Contractor Involvement and securing consents.</p> <p>The intention is that the construction shall take place during the summer of 2022, should funding be located.</p>

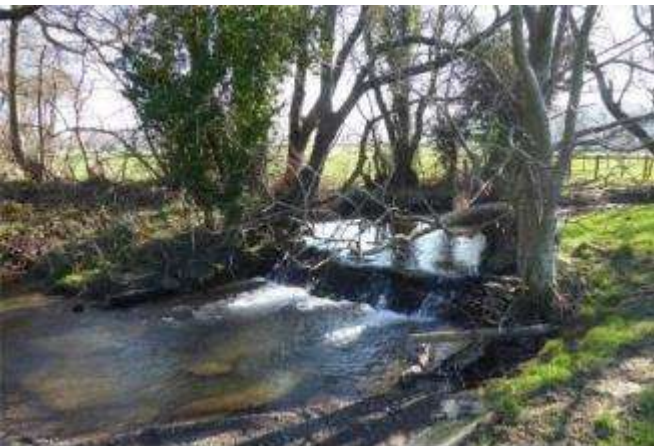
<p>Barrier at Pentreheyling on the Caebitra</p>

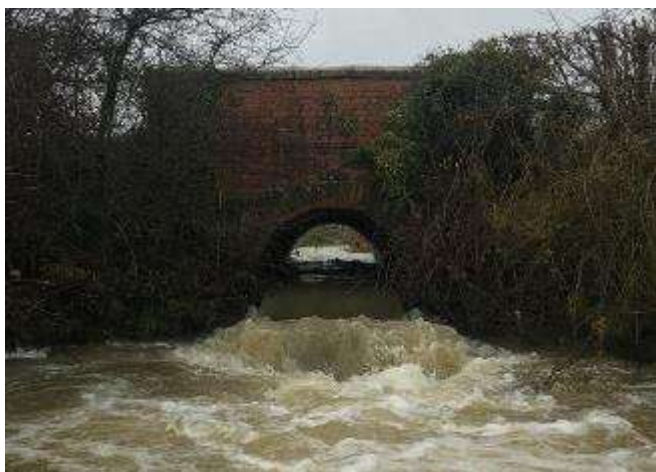
Barrier at Red Bridge on the Llifior Brook

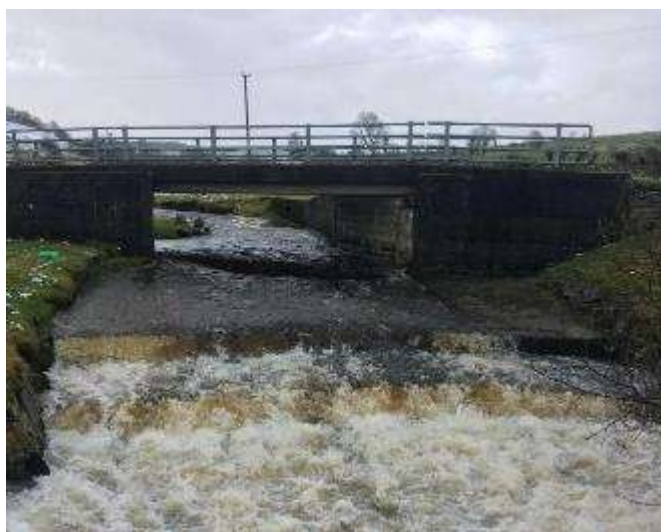
Barrier on the Cledan

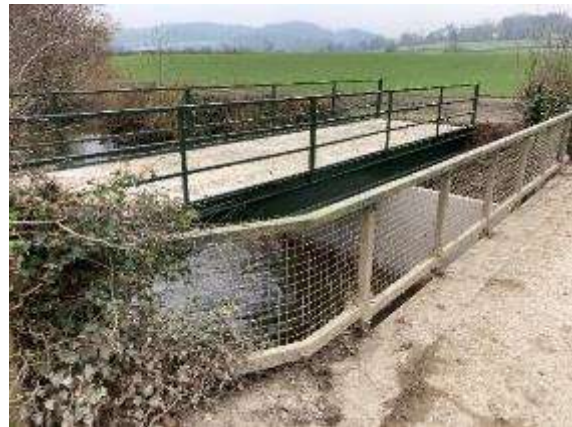
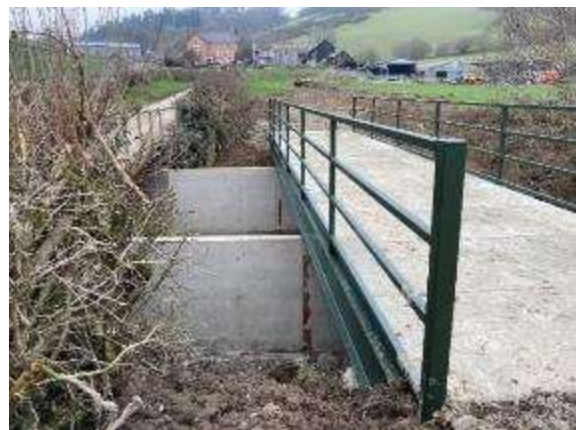
The new cattle bridge.

Project	Green Hall cattle bridge
Action	Installation of cattle bridge and access track.
NGR	SJ16481889
Cost	£16,372
Story	<p>The landowner at Green Hall is involved with the Cain Valley Sustainable Land and Water Management project. Due to funding delays brought about by the Covid19 pandemic, no funds were available under the SMS project for these works. The landowner does have a good relationship with Severn Rivers Trust and is in regular contract with the SMS project manager.</p> <p>300 cattle cross the river Cain at Green Hall Farm daily between April and October. They are housed in the winter.</p> <p>A cattle bridge was installed by local contractor Gareth Jones, on the recommendation of local farmers to remove this access.</p>

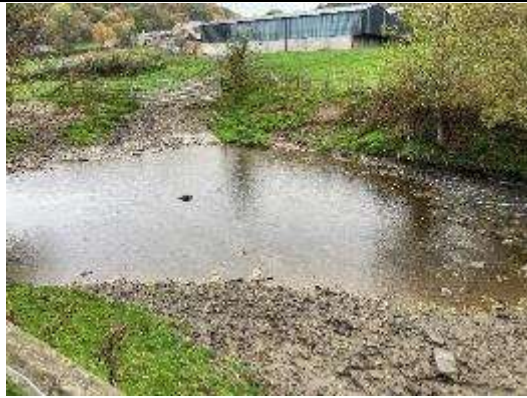
Photos showing cattle crossing.

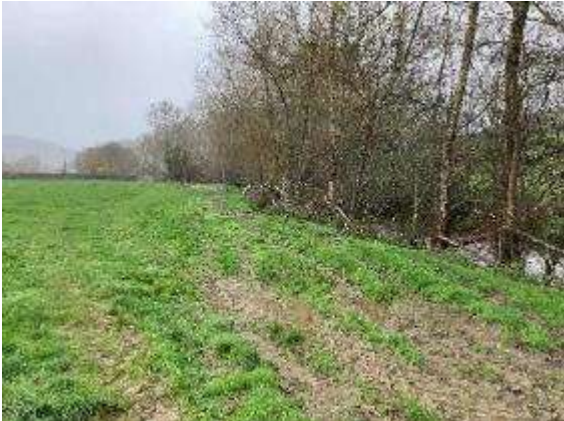
Action	Fencing 250m of riverbank and associated tree works.
NGR	SJ16185290
Cost	£7,444.68
Story	<p>The landowner at Green Hall is involved with the Cain Valley Sustainable Land and Water Management project. Due to funding delays brought about by the Covid19 pandemic, no funds were available under the SMS project for these works. The landowner does have a good relationship with Severn Rivers Trust and is in regular contract with the SMS project manager. The banks of the river Cain at Green Hall Farm, Llanfyllin are eroding, and large willows are at risk during flood events.</p> <p>Barry Thomas was contracted locally to:</p> <ul style="list-style-type: none"> • Pletch the willows • Erect 250m of stock fencing to protect regrowth from sheep grazing.
Photos Before	Photos after
  <p>View from right hand bank upstream, showing location of new fencing and willows to be pletched.</p>

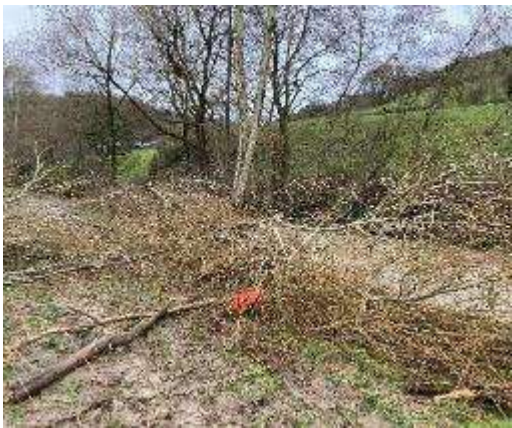
<p>Pletched willows on the right hand bank.</p>

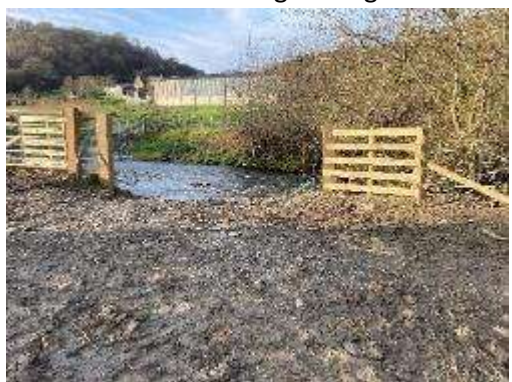
<p>Location for gate.</p>

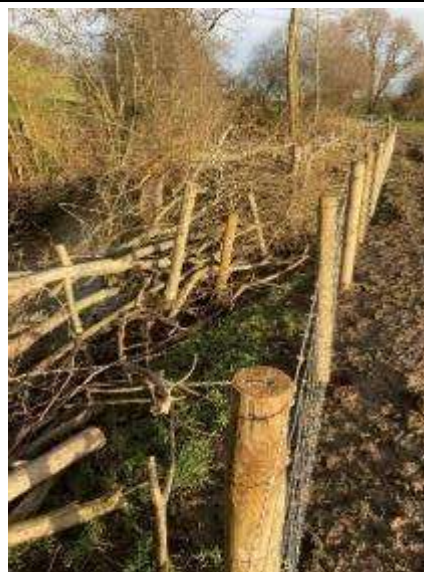
View from right hand bank downstream, showing location of new fencing and willows to be pletched.

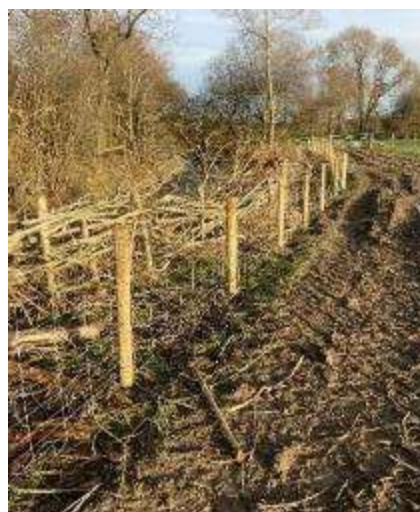
New fencing and pletched willows above and below.

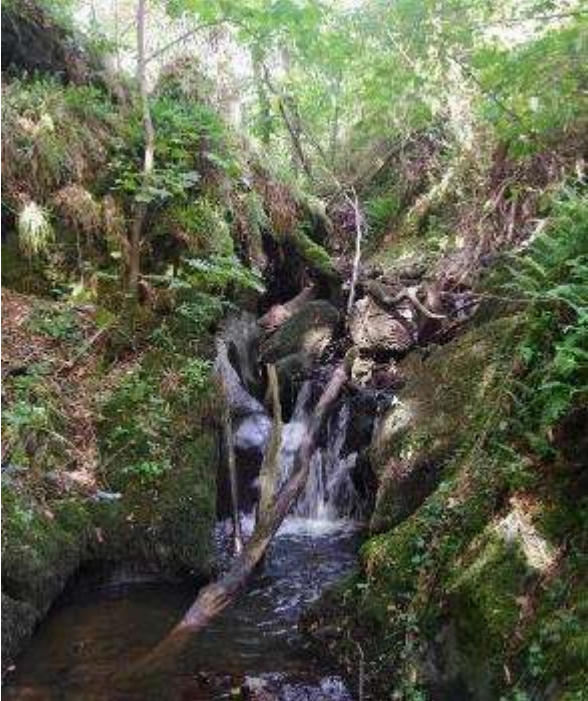
<p>The large (2.5m) boulder and fallen tree/debris blockage in a gorge just upstream of a rockramp easement.</p>

NGR	SJ 04497 58293	
Cost	£4860	
Story	<p>The Afon Concwest is a tributary of the Clywedog sub-catchment of the Clwyd near Cyffylliog, Ruthin. A Fisheries Habitat Restoration Survey by the Trust identified a barrier to fish migration consisting of a large debris/boulder blockage in a gorge near the confluence with the Clywedog. NRW electrofishing surveys have found no salmonids upstream of this point, while good stocks remain downstream. The project aimed to improve fish passage over the structure by removing the obstruction and installing a boulder prebarrage downstream.</p>	
Photos Before		Photos After

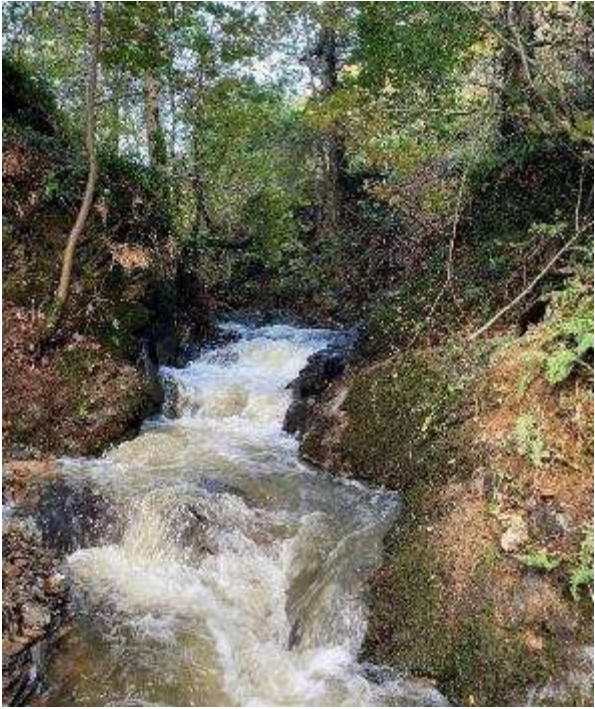
<p>The cleared obstruction with boulder prebarrage in the foreground.</p>
Lessons learned

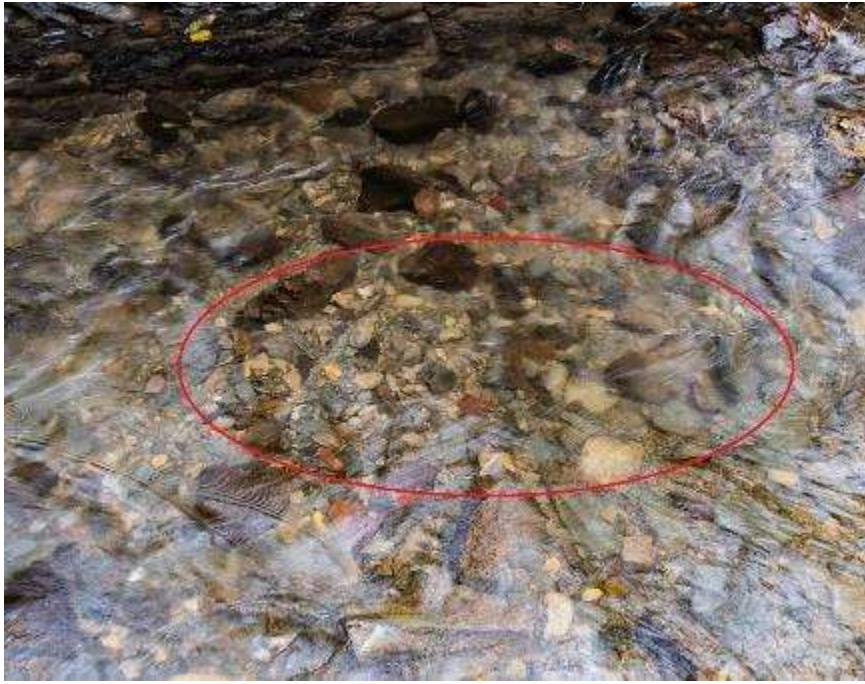
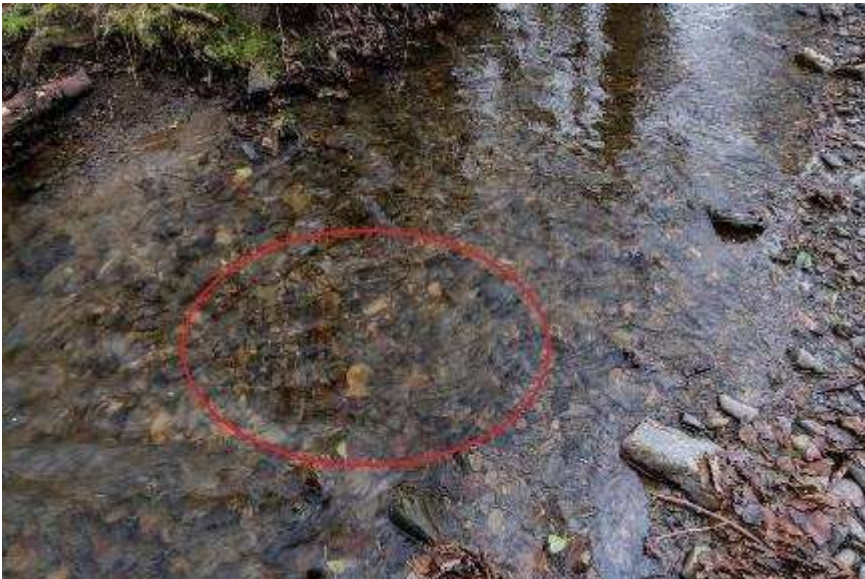
Two

trout/seatrout redds observed upstream of the fish easements in November 2020. This is significant as NRW electrofishing data shows no salmonids upstream of the project site in recent years.

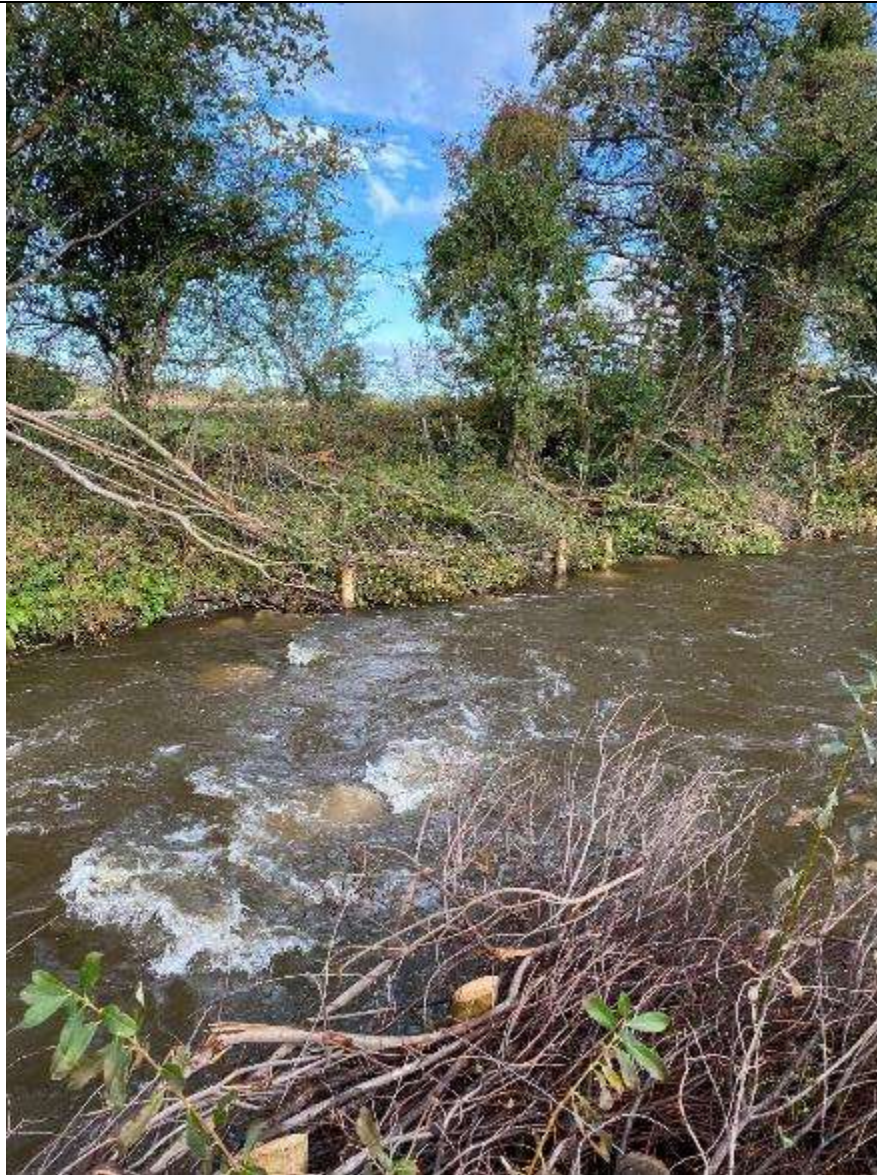
Detail of nearside and far bank brush revetment and in -river boulder placement to give flow variation and refuge structure.

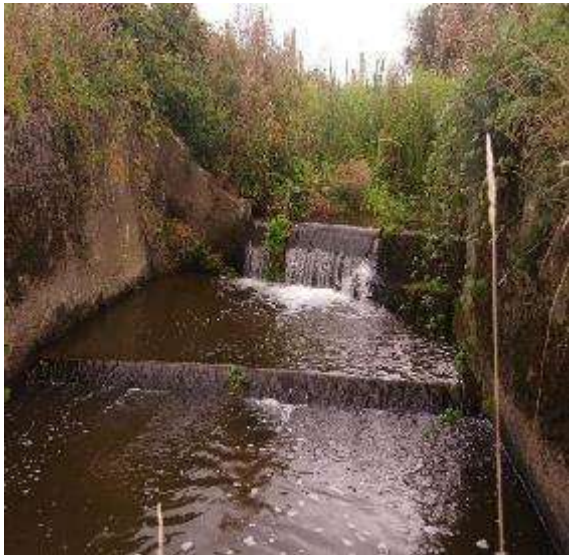
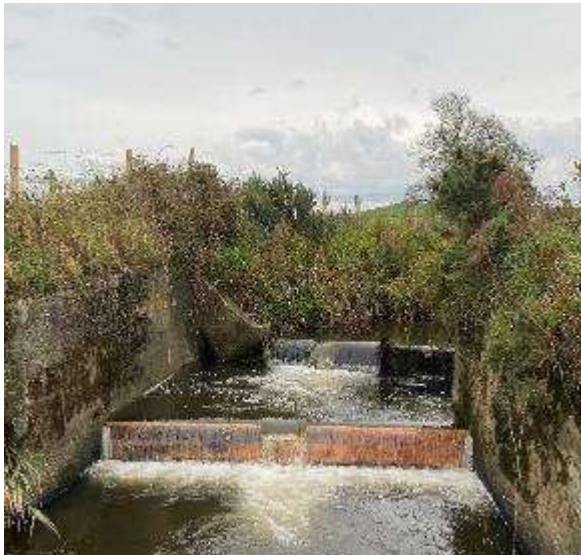
Weir before		Weir with notch and removable timber prebarrage

Project	Afon Wygyr/Meddanen weir easements	
NGR	SH 37847 92137	
Cost	£4980	
Action	Pre-barrage and weir notch easements	
Story	Easements were completed on two small concrete weirs at the confluence with the Wygyr and Meddanen near Cemaes Anglesey. The structures are associated with a historic water works and could not be removed. The weirs were notched at centre and removable timber pre-barrages installed to reduce the overall height. The project also involved the clearing of an obstructive reed bed at the confluence and selective thinning of dense overshading vegetation upstream.	
Photos Before		Photos After

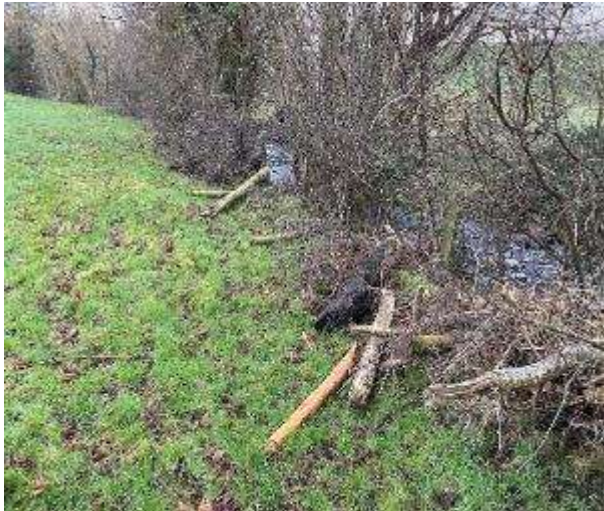
Typical flood damaged fence	
Photos after

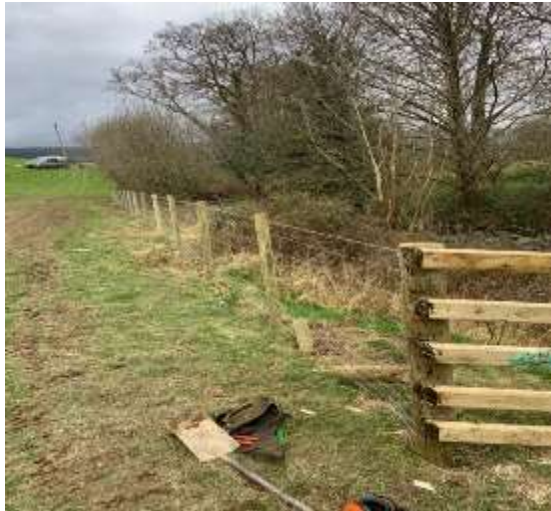
Replaced fence

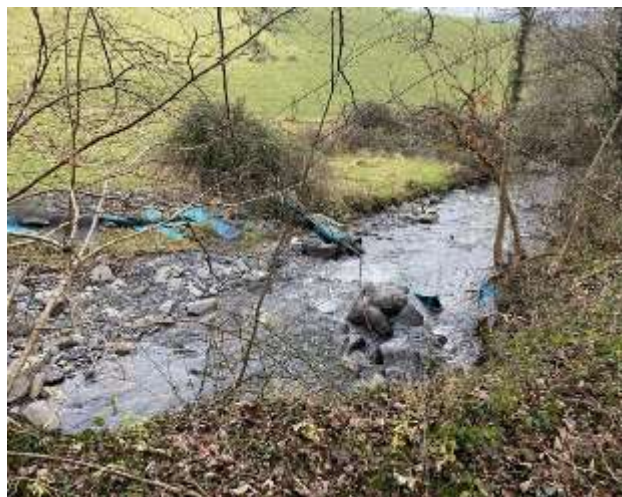
Old drinking bay destroyed by flooding

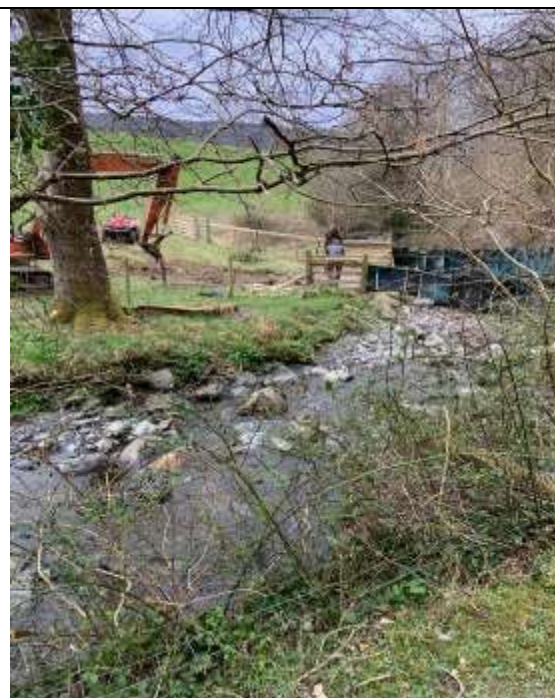
Installation of new drinking bay

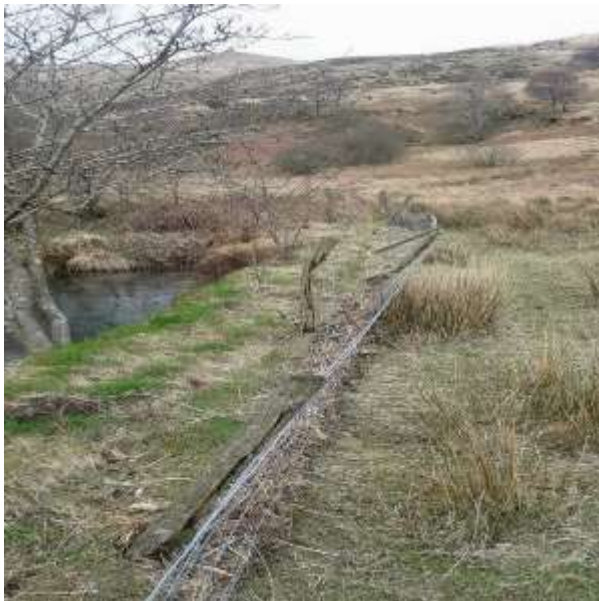
<p>Typical flood damaged/redundant fence</p>

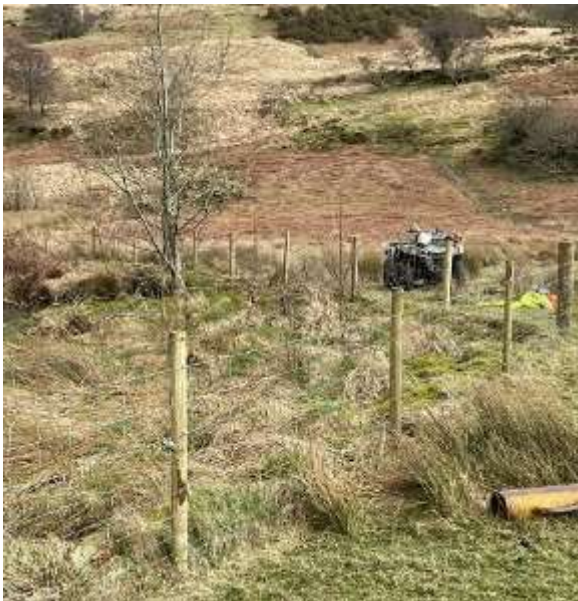
<p>New fence installed.</p>

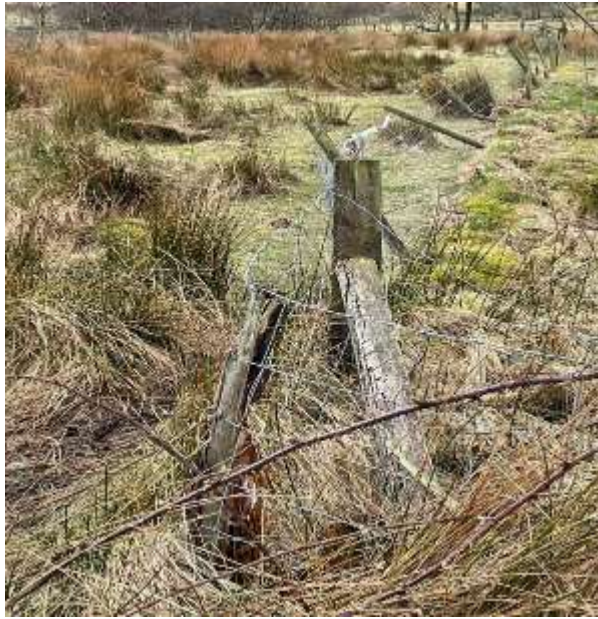
Old ineffective fence

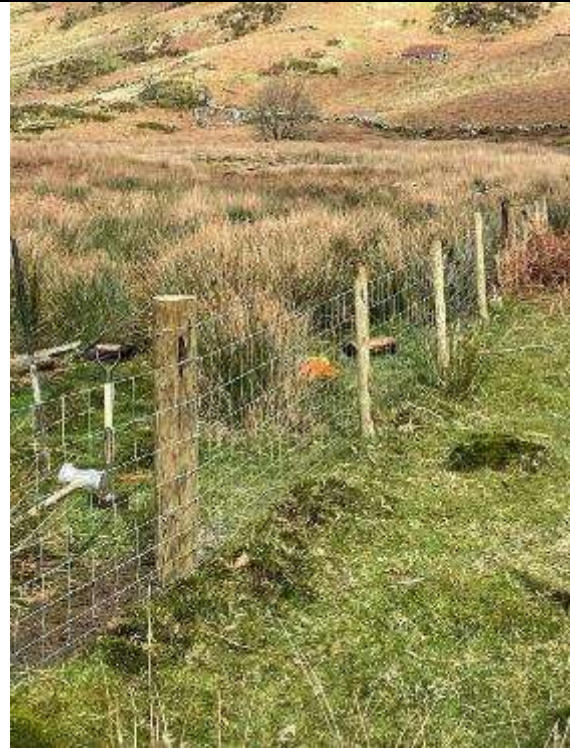
New fence being installed
